## **Lafayette Square**

Accessibility Review

City of Duluth, MN

2013

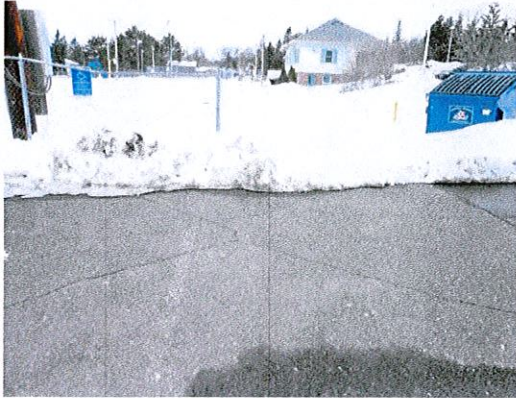
**Photo 1:** Re-stripe the accessible parking space (currently faded). Ensure the aisle aligns with the route the upper and lower levels.

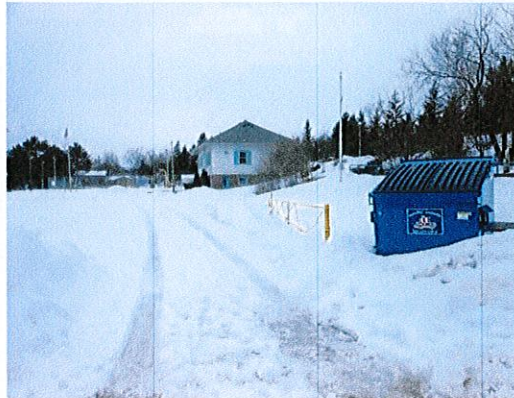
14D1	16490 Provide a fully compliant elevator to provide access between levels. MN 1341 1104.4 and 402.2 <i>There is not currently an interior accessible route between the levels. (On-grade entries are provided to both levels.) There is minimal program interaction between the upper and lower levels; no action recommended at this time.</i>	1	\$0	\$0	4				
------	---	---	-----	-----	---	--	--	--	--

**Photo 2:** There is an on-grade entry to the upper and lower levels. There is not an interior accessible route between levels (stairs only).

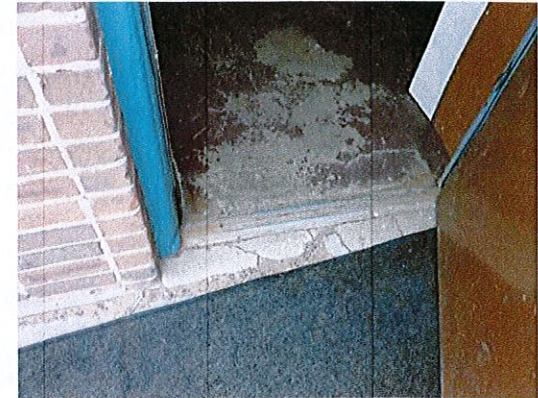
**Photo 3:** Patch the threshold at the lower level entry.

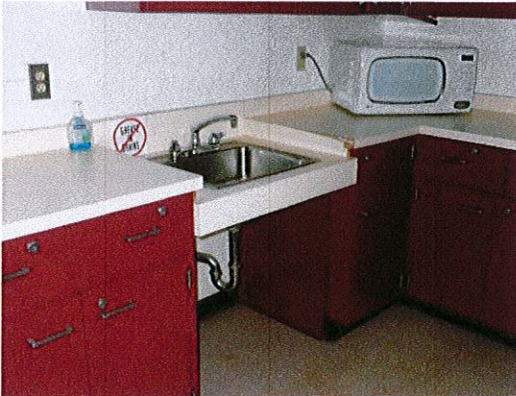
Location	Solution / Comments	Qty	Unit Cost	Total Cost	Priority	Estimated Compl. Date	Person Responsible	Actual Compl. Date	Actual Cost
JQP # / Item #									
<b>Kitchen</b>									
20C	16471 Relocate door and frame to provide needed maneuvering clearance at the door. ICC / ANSI 404.2.3, Table 404.2.3.1 <i>Currently provides 10" (vs. 12" minimum). The door is propped in the 'open' position.</i>	1	\$1,500	\$1,500	4				
22Q	16470 Insulate or otherwise protect exposed pipes at lavatory. ICC / ANSI 606.6	1	\$50	\$50	4				
25J9	16469 Create an accessible kitchen, including: roll under work surface, roll under sink, range with front or side controls, and compliant clearances. ANSI 804 <i>There is a full kitchen. The sink currently provides 26" knee clearance (vs. 27" minimum). There is not currently a section of work surface with knee and toe clearance. Photo 4.</i>	1	\$7,000	\$7,000	4				
				<i>Location Subtotal:</i>	\$8,550

**Photo 4:** A sink with 26" (vs. 27" minimum) knee clearance is currently provided in the kitchen.

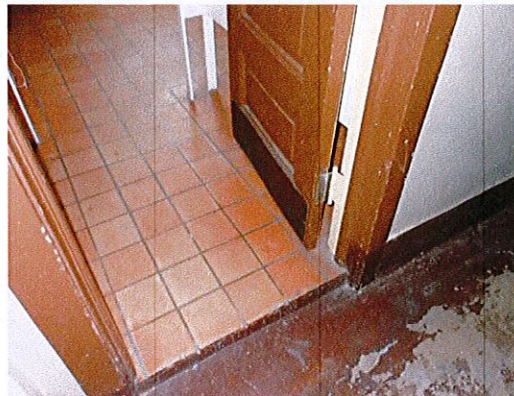
22.1	16489 Upgrade toilet room to be fully accessible. IBC 1109.2 <i>There are currently no features of accessibility provided. There is a 3" rise into the room and the door provides a 27" clear opening. Photo 5.</i>	1	\$10,000	\$10,000	4				
------	---	---	----------	----------	---	--	--	--	--

Location	Solution / Comments	Qty	Unit Cost	Total Cost	Priority	Estimated Compl. Date	Person Responsible	Actual Compl. Date	Actual Cost
JQP # / Item #									
<b>Women's Toilet Room- Lower Level</b>									
22.1	16488 Upgrade toilet room to be fully accessible. IBC 1109.2 <i>There are currently no features of accessibility provided. There is a 3" rise into the room and the door provides a 26 1/2" clear opening. Photo 5.</i>	1	\$10,000	\$10,000	4				
				<b>Priority # 4 Total</b>	<b>\$33,650</b>

**Photo 5:** There is currently a 3" rise into the lower level toilet rooms. No features of accessibility are provided within the toilet rooms.

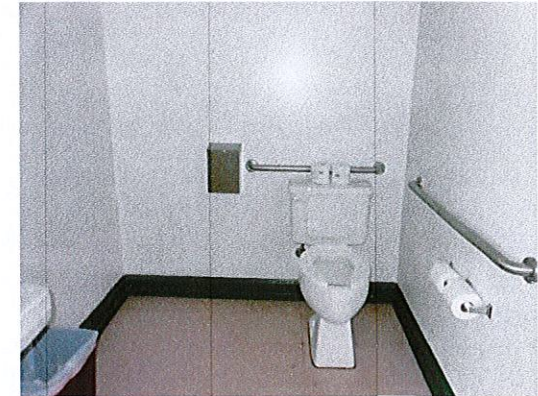
Location	Solution / Comments	Qty	Unit Cost	Total Cost	Priority	Estimated Compl. Date	Person Responsible	Actual Compl. Date	Actual Cost
<b>Men's Toilet Room- Upper Level</b>									
22K1 (MN) 16474	Install compliant vertical grab bar on the side wall of the water closet. MN 1341 604.5.1	1	\$200	\$200	2				
22Q 16476	Insulate or otherwise protect exposed pipes at lavatory. ICC / ANSI 606.6	1	\$50	\$50	2				
				<i>Location Subtotal:</i>					\$250
<b>Women's Toilet Room- Upper Level</b>									
22K1 (MN) 16478	Install compliant vertical grab bar on the side wall of the water closet. MN 1341 604.5.1 <i>Photo 6.</i>	1	\$200	\$200	2				
22Q 16480	Insulate or otherwise protect exposed pipes at lavatory. ICC / ANSI 606.6	1	\$50	\$50	2				
22W2 16481	Relocate the sanitary product receptacle in the accessible stall. The sanitary product receptacle should be located 1 1/2" minimum below the horizontal grab bar and 18" minimum above the floor and 12"- 40" from the rear wall. MN 1341 604.7 <i>Photo 6.</i>	1	\$50	\$50	2

**Photo 6:** The upper level toilet rooms have been remodeled to provide features of accessibility. *This is a good example of accessibility.* Add a vertical grab bar and relocate the sanitary waste receptacle to below the side grab bar.

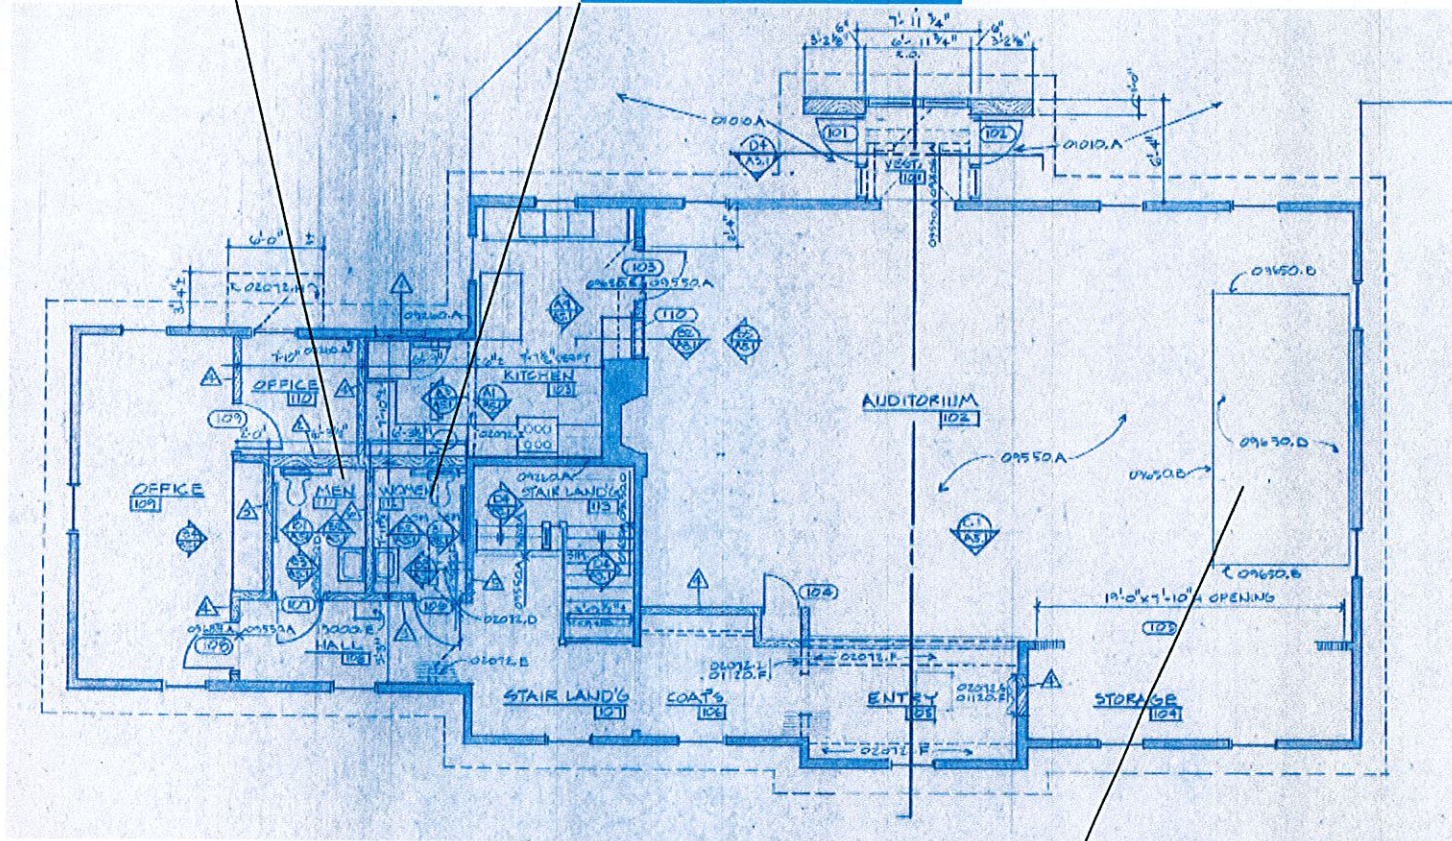
Install vertical grab bar  
 Insulate pipes at lavatory  
 Add raised and braille sign  
 Add a full height mirror

Install vertical grab bar  
 Insulate pipes at lavatory  
 Relocate sanitary waste receptacle  
 Add raised and braille sign  
 Add a full height mirror

Bevel rise between asphalt and deck to beach

Parking  
 Re-stripe faded accessible parking spaces

Provide a ramp up to the stage

Install door lever hardware
