Observation Community Club

Accessibility Review

Transition Plan - (location/priority)

City of Duluth, MN

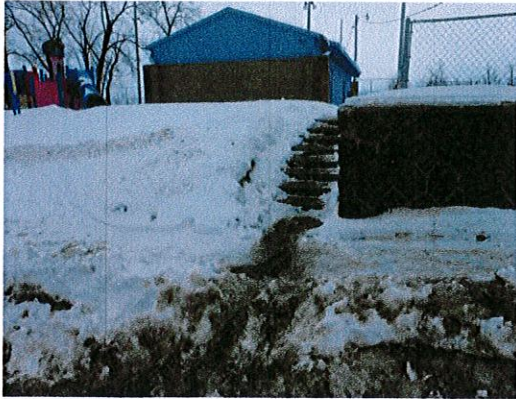
Photo 1: There is not currently an accessible route to the building entry.

Location JQP # / Item #	Solution / Comments	Qty	Unit Cost	Total Cost	Priority	Estimated Compl. Date	Person Responsible	Actual Compl. Date	Actual Cost
Main Entry									
08A 16343	Provide an accessible route. IBC 1104 <i>There are 8 exterior stairs up from the sidewalk/street. Photo 1.</i>	1	\$20,000	\$20,000	2				
12B1 16345	Extend sidewalk to provide appropriate maneuvering clearance on the latch side of the door. ICC / ANSI 404.2.3.1 <i>Photo 2.</i>	1	\$500	\$500	2				
				<i>Location Subtotal:</i>					\$20,500
									Priority # 2 Total \$20,500

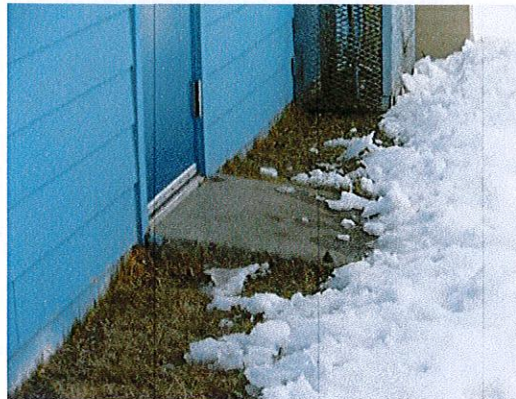
Photo 2: Replace the concrete stoop to eliminate the rise at the threshold, enlarge to provide maneuvering clearance and eliminate the slope at the entry.

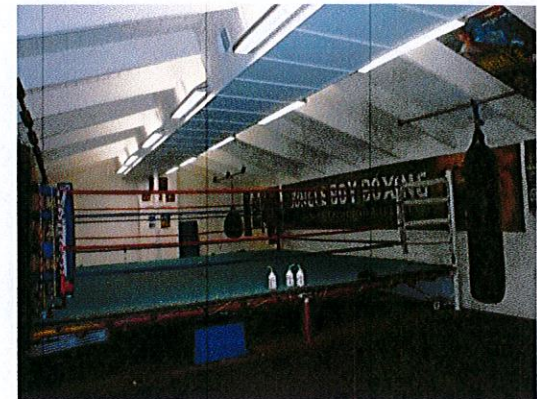
Photo 3: This location is currently used as a boxing gym.

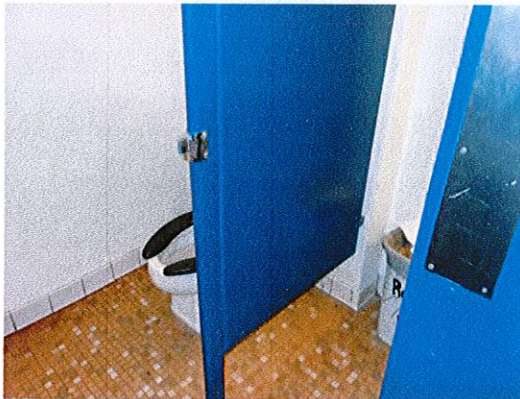
Photo 4: View of toilet room. There are currently no features of accessibility provided.

Location JQP # / Item #	Solution / Comments	Qty	Unit Cost	Total Cost	Priority	Estimated Compl. Date	Person Responsible	Actual Compl. Date	Actual Cost
Building Wide									
14E1 16358	Remove / relocate / modify object to provide a minimum clear width of 36". ICC / ANSI 403.5 <i>There is currently 26" between the wall and the boxing ring.</i>	1	\$2,000	\$2,000	3				
Main Entry									
12H 16344	Bevel / replace / reset threshold so there is no abrupt rise greater than 1/2" or slope greater than 1:2. ICC / ANSI 404.2.4 <i>Photo .</i>	1	\$200	\$200	3				
Men's Toilet Room									
22B 16354	Install signage with appropriate raised and Braille lettering. MN 1341 1110.2	1	\$40	\$40	3				
Women's Toilet Room									
22B 16349	Install signage with appropriate raised and Braille lettering. MN 1341 1110.2	1	\$40	\$40	3				
22D 16351	Remove interior partitions to create a single use toilet room. It is recommended that a privacy lock be installed. ICC / ANSI 603.2 <i>The room is 71" x 90". It will not be possible to provide 48" in front of the toilet (can provide 41"). Photo 4.</i>	1	\$1,500	\$1,500	3
