Portman Community Club

Portman Community Club is a 2-story building- the lower level is a warming house with toilet rooms; the upper level has a large open meeting/assembly room, office, full kitchen and toilet rooms. On-grade entries with an accessible route are provided to both levels. There is not currently an interior accessible route between levels (it does not appear that there is currently user interaction between the 2 levels). The toilet rooms on the upper level have been modified and converted to single-user toilet rooms that provide many features of accessibility. There are currently no features of accessibility provided in the lower level toilet rooms.

Accessibility Review

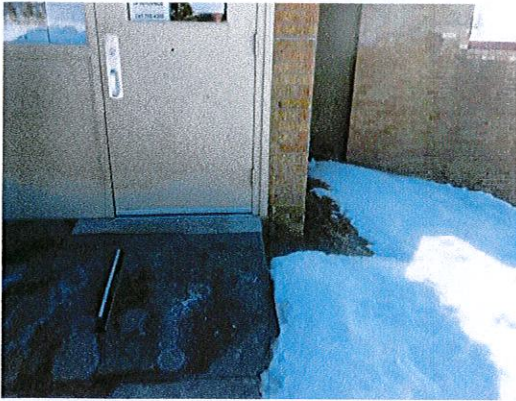
Photo 1: Modify to provide level (2% max) maneuvering space at the upper level entry door.

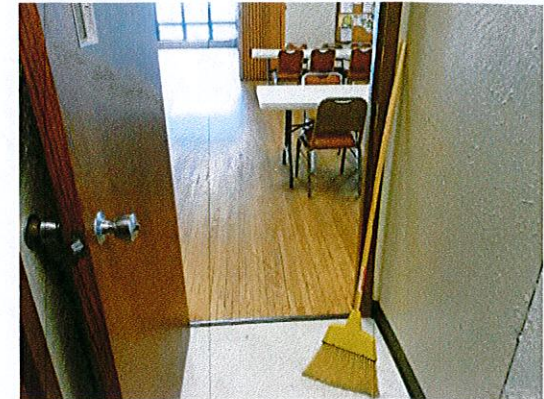
Photo 3: Maneuvering clearance is not currently provided at the single door into the community room. Replace the knob style hardware.

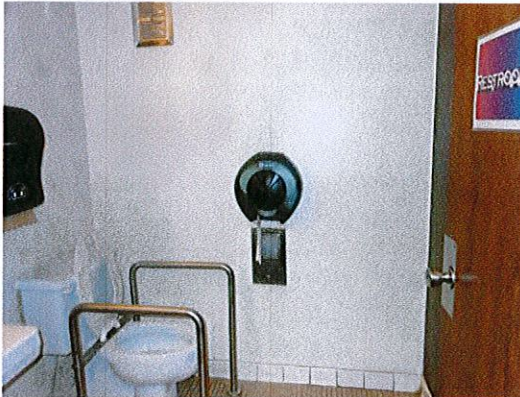
Location JQP # / Item #	Solution / Comments	Qty	Unit Cost	Total Cost	Priority	Estimated Compl. Date	Person Responsible	Actual Compl. Date	Actual Cost
Single User Toilet Room- Upper Level Lobby									
22-20D 16236	Provide door hardware that does not require grasping, pinching or twisting to operate, such as lever, push pull, etc. ICC / ANSI 404.2.6	1	\$250	\$250	3				
22B 16235	Install signage with appropriate raised and Braille lettering. MN 1341 1110.2	1	\$40	\$40	3				
22C4 16242	Alter swing of entry door so it does not intrude on the clear floor space of any fixture. ICC / ANSI 603.2.3	1	\$150	\$150	3				
22K6 (MN) 16240	Remove the existing grab bar configuration and replace with a compliant grab bar configuration. MN 1341 604.5.1 ANSI 604.5.2 <i>Photo 4.</i>	1	\$400	\$400	3				
22L (MN) 16241	Reposition the toilet paper dispenser so it is located below the horizontal grab bar. Operable parts should be located within an area 12" - 40" from the rear wall, and 18" minimum above the floor and 1 1/2" minimum below the horizontal grab bar. MN 1341 604.7 <i>Photo 4.</i>	1	\$50	\$50	3

22Q 16237	Insulate or otherwise protect exposed pipes at lavatory. ICC / ANSI 606.6 <i>Photo 4.</i>	1	\$50	\$50	3				
22R 16238	Replace the existing lavatory faucet with hardware that does not require grasping, pinching or twisting to operate. ICC / ANSI 309.4, 606.4 <i>Photo 4.</i>	1	\$450	\$450	3				
22V 16239	Install a full-height mirror or provide a mirror where the bottom of the reflective surface is no higher than 40" above the floor. MN 1341 603.3 <i>Currently at 47".</i>	1	\$300	\$300	3				
				<i>Location Subtotal:</i>					\$1,690
Storage- Lower Level									
20D 16263	Provide door hardware that does not require grasping, pinching or twisting to operate, such as lever. ICC / ANSI 404.2.6	1	\$250	\$250	3

Photo 4: View of lobby single user toilet room. Replace the existing grab bar configuration with compliant side and rear wall grab bars. Replace the knob style hardware.

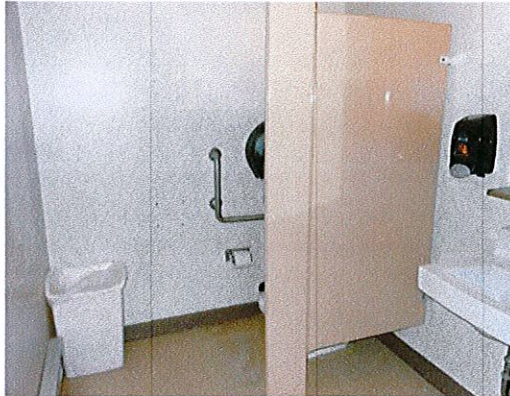
Location JQP # / Item #	Solution / Comments	Qty	Unit Cost	Total Cost	Priority	Estimated Compl. Date	Person Responsible	Actual Compl. Date	Actual Cost
Single User Toilet Room- Upper Level									
22D 16250	Remove interior partitions to create a single use toilet room. It is recommended that a privacy lock be installed. ICC / ANSI 603.2 <i>Photo 5.</i>	1	\$1,500	\$1,500	2				
22K6 (MN) 16251	Remove the existing grab bar configuration and replace with a compliant grab bar configuration. MN 1341 604.5.1 ANSI 604.5.2 <i>Photo 5.</i>	1	\$400	\$400	2				
22L (MN) 16252	Reposition the toilet paper dispenser so it is located below the horizontal grab bar. Operable parts should be located within an area 12" - 40" from the rear wall, and 18" minimum above the floor and 1 1/2" minimum below the horizontal grab bar. MN 1341 604.7 <i>There is currently a small dispenser below the grab bar and a large dispenser above the grab bar. Photo 5.</i>	1	\$50	\$50	2

22Q 16248	Insulate or otherwise protect exposed pipes at lavatory. ICC / ANSI 606.6 <i>Photo 5.</i>	1	\$50	\$50	2				
22V 16249	Install a full-height mirror or provide a mirror where the bottom of the reflective surface is no higher than 40" above the floor. MN 1341 603.3 <i>Currently at 45". Photo 5.</i>	1	\$300	\$300	2				
22Z 16253	Provide a coat hook positioned so the highest operable part is no higher than 48". ICC / ANSI 604.11 <i>Photo 5.</i>	1	\$50	\$50	2				
				<i>Location Subtotal:</i>					\$2,350
									Priority # 2 Total \$2,350

Photo 5: View of the upper level single user toilet room. Remove the privacy partition to provide clearance at the toilet.

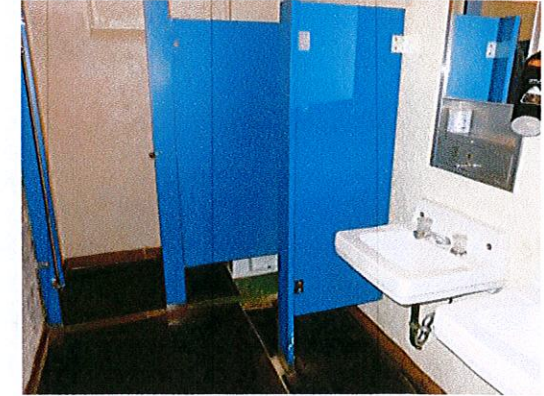
Location JQP # / Item #	Solution / Comments	Qty	Unit Cost	Total Cost	Priority	Estimated Compl. Date	Person Responsible	Actual Compl. Date	Actual Cost
Men's Toilet Room- Lower Level									
22-20A 16265	Widen door opening to provide a minimum 32" clear opening. ICC / ANSI 404.2.2 <i>Currently provides a 29" clear opening.</i>	1	\$1,500	\$1,500	4				
22E 16270	Enlarge to provide a fully compliant 60" minimum wide toilet stall. MN 1341 604.3.1 <i>There are currently no features of accessibility provided. There is 1 toilet, 1 urinal and 2 sinks. Photo 6.</i>	1	\$1,350	\$1,350	4				
				<i>Location Subtotal:</i>					\$2,850

Location JQP # / Item #	Solution / Comments	Qty	Unit Cost	Total Cost	Priority	Estimated Compl. Date	Person Responsible	Actual Compl. Date	Actual Cost
Women's Toilet Room- Lower Level									
22-20A 16280	Widen door opening to provide a minimum 32" clear opening. ICC / ANSI 404.2.2 <i>Currently provides a 29" clear opening.</i>	1	\$1,500	\$1,500	4				
22-20B 16286	Re-hinge / relocate door to provide needed maneuvering clearance on the latch pull side of the door. ICC / ANSI 404.2.3, Table 404.2.3.1 <i>Currently provides 2".</i>	1	\$750	\$750	4				
22E 16285	Enlarge to provide a fully compliant 60" minimum wide toilet stall. MN 1341 604.3.1 <i>There are currently no features of accessibility provided. There are 2 toilets and 2 sinks. Photo 6.</i>	1	\$1,350	\$1,350	4				
				<i>Location Subtotal:</i>					\$3,600
									Priority # 4 Total \$54,200

Photo 6: View of lower level toilet rooms. There are currently no features of accessibility provided.
