## **Washington Center**

Washington Center

Accessibility Review

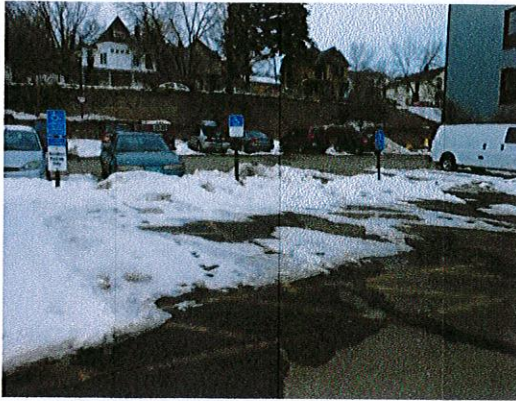
Location JQP # / Item #	Solution / Comments	Qty	Unit Cost	Total Cost	Priority	Estimated Compl. Date	Person Responsible	Actual Compl. Date	Actual Cost
<b>Parking</b>									
05A 16573	Stripe an appropriate number of accessible parking stalls and provide appropriate permanent signage. IBC 1106.1 <i>There are approximately 15 public parking spaces (the remainder are reserved for residents), currently no public spaces have been designated as accessible. Photo 1.</i>	1	\$400	\$400	2				
				<b>Priority # 2 Total</b>	<b>\$400</b>

**Photo 1:** Currently the designated accessible parking spaces are reserved for resident parking.

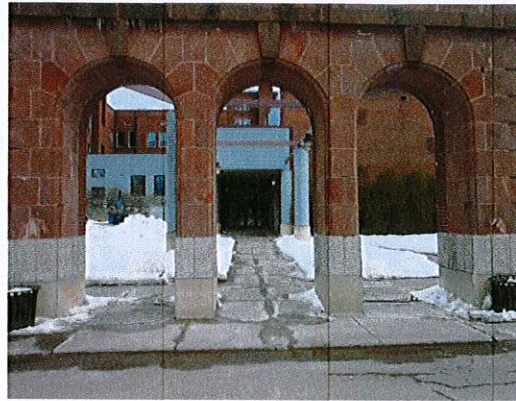
There is not currently accessible parking designated associated with Washington Center (all designated accessible parking is reserved for the residential units). An on-grade route is provided from the parking lot to the main entry, however the surface of the route is deteriorating.

**Photo 2:** Patch the accessible route to eliminate any changes in elevation greater than 1/2".

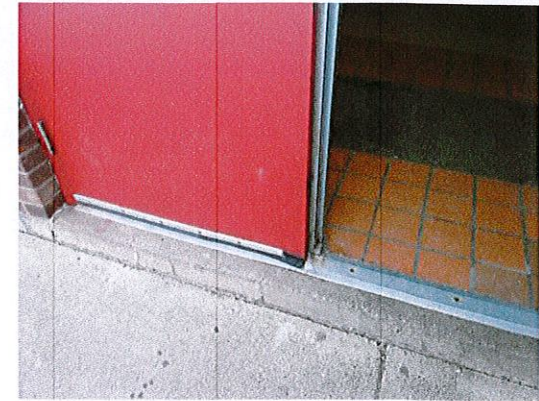
<i>Location Subtotal:</i>					\$1,390
<b>Men's Toilet Room- Pool</b>									
22.1	16560 Upgrade toilet room to be fully accessible. IBC 1109.2	1	\$10,000	\$10,000	3				
22B	16559 Install signage with appropriate raised and Braille lettering. MN 1341 1110.2	1	\$40	\$40	3				
				<i>Location Subtotal:</i>					\$10,040
<b>SW Entry</b>									
08D	16542 Bevel abrupt rises in the sidewalk. ANSI 303.3 <i>Currently a 6" rise at the concrete stoop. Photo 3.</i>	1	\$500	\$500	3

**Photo 3:** Eliminate the 6" rise at the SW entry. (This is the primary entry used by ECFE staff.)

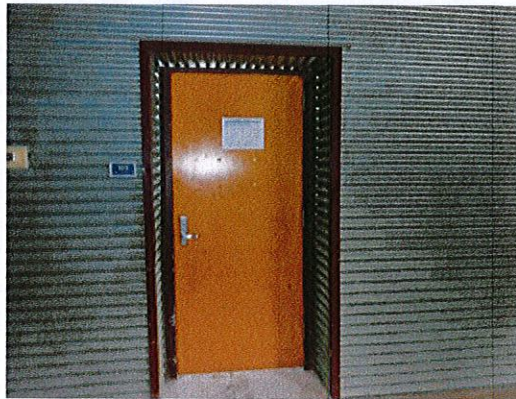
Location	Solution / Comments	Qty	Unit Cost	Total Cost	Priority	Estimated Compl. Date	Person Responsible	Actual Compl. Date	Actual Cost
JQP # / Item #									
<b>Building Wide</b>									
40B	16536	Provide compliant raised and Braille permanent room identification signage. MN 1341 1110.2 <i>Raised and braille signs are provided, currently many of the signs are missing.</i>	15	\$40	\$600	3			
<b>Exterior Route</b>									
07G	16574	Patch lip at the base of the curb cut / ramp so there is no abrupt rise greater than 1/2". ICC / ANSI 303 <i>Photo 2.</i>	1	\$50	\$50	3			
08D	16575	Bevel abrupt rises in the sidewalk. ANSI 303.3 <i>Photo 2.</i>	1	\$500	\$500	3			
				<i>Location Subtotal:</i>					\$550
<b>Gym</b>									
20A1	16572	Modify widths of double doors (1 large/1small) to provide a single leaf with a minimum 32" clear opening. ICC / ANSI 404.2.2 <i>There is 1 entry door that provides a 32" clear opening, it is recessed and does not provide maneuvering clearance. There are 3 sets of double doors- a single leaf of the double door currently provides a 27" clear opening. Photos 4 and 5.</i>	1	\$1,500	\$1,500	3

**Photo 5:** There is 1 door into the gym that provides a 32" clear opening, however the door is recessed and does not provide maneuvering clearance.

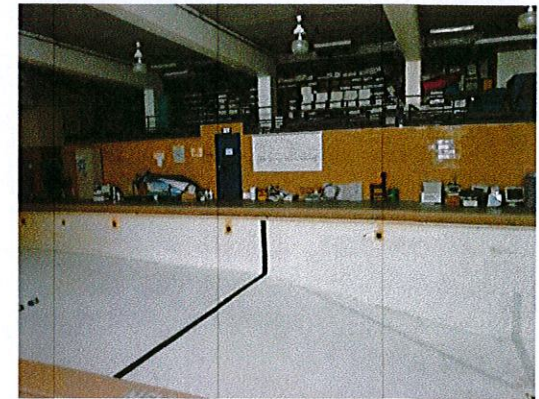
Location JQP # / Item #	Solution / Comments	Qty	Unit Cost	Total Cost	Priority	Estimated Compl. Date	Person Responsible	Actual Compl. Date	Actual Cost
<b>Pool</b>									
66A	16570 Provide a ramp or lift to access the water. IBC 1111.2 <i>All of the water has currently been drained from the pool and the room is used for storage. If it is used as a pool again, provide access into the water. Photo 6.</i>	1	\$5,000	\$5,000	4				
66B	16571 Identify accessible viewing positions on the pool deck. IBC 1108.2 <i>There is not currently an accessible route to the spectator seating area. Currently the pool area is used for storage.</i>	1	\$0	\$0	4				
<b>SW Entry</b>									
20P	16543 Lower the window in the door (or the sidelite) so the bottom is at 43" maximum. ICC / ANSI 404.2.10 <i>Currently at 45".</i>	1	\$250	\$250	4

**Photo 6:** The pool is currently empty and the space is used for storage. If the pool is used in the future; ensure a compliant pool lift is provided.

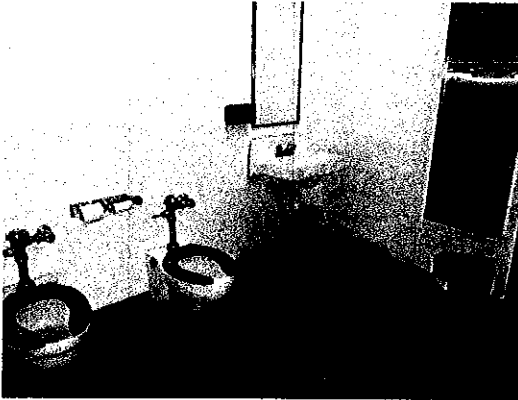
22Z 16555	Provide a coat hook positioned so the highest operable part is no higher than 48". ICC / ANSI 604.11	1	\$50	\$50	3				
23P (MN) 16558	Relocate the lavatory to provide a minimum knee clearance height of 24". Ensure the rim or counter surface is no higher than 31". ANSI 606.2, Exception 3 <i>This location is currently use by ECFE students, a door has been added from the corridor. Lower the sink to children's standards. (There is currently a wood platform below the sink.) Photo 7.</i>	1	\$450	\$450	3				
				<i>Location Subtotal:</i>					\$1,690
				<b>Priority # 3 Total</b>					<b>\$16,510</b>

**Photo 7:** View of toilet room. Lower the sink to children's standards at this location to eliminate the need for the wood platform.

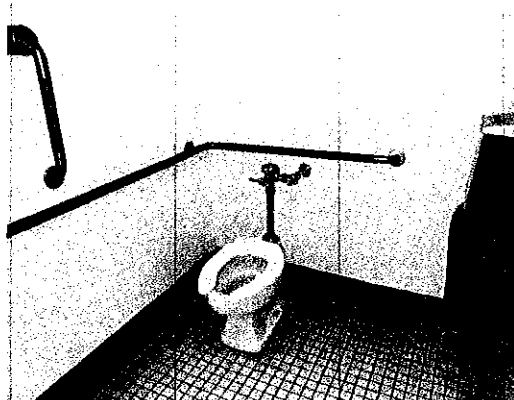
22W2	16569 Relocate the sanitary product receptacle in the accessible stall. The sanitary product receptacle should be located 1 1/2" minimum below the horizontal grab bar and 18" minimum above the floor and 12"- 40" from the rear wall. MN 1341 604.7 <i>Photo 8.</i>	1	\$50	\$50	3				
				<i>Location Subtotal:</i>					\$240

**Photo 8:** The toilet rooms have been remodeled to provide features of accessibility. In the women's toilet room relocate the toilet paper dispenser and sanitary waste receptacle to below the side grab bar.
