Fire Station 1

Fire Station 1 is the main fire station and is located in downtown Duluth. The 3 story building has on-grade routes to the main level and lower level. There is not currently an accessible route between levels. As the main fire station, the fire chief's office is located on the 3rd (upper) level of the building. There are currently no features of accessibility provided within the building.

Accessibility Review

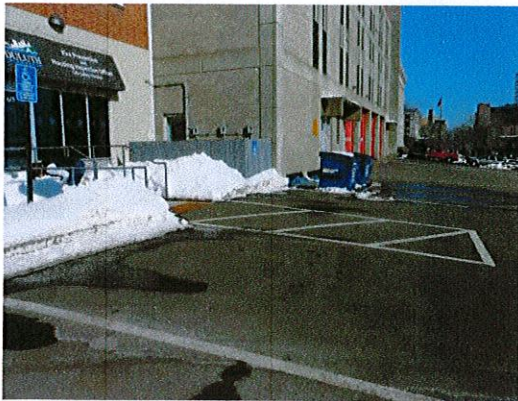
Photo 1: The designated accessible parking currently has a slope of 8.2%. Modify to 2% maximum in any direction.

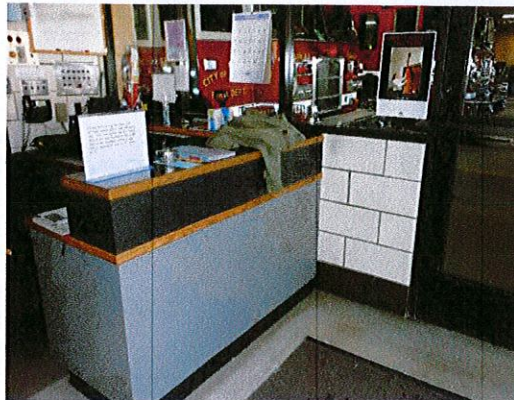
Photo 2: The counter at main entry is currently at 40 1/2". A sign currently directs visitors to go up to the administration office (there is not an accessible route provided).

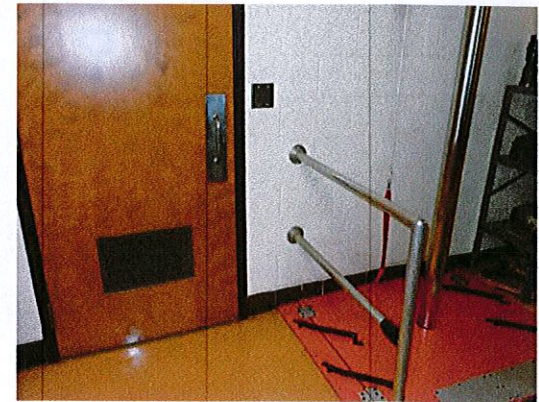
Photo 3: The fire pole obstructs the maneuvering clearance to the administration office.

Location JQP # / Item #	Solution / Comments	Qty	Unit Cost	Total Cost	Priority	Estimated Compl. Date	Person Responsible	Actual Compl. Date	Actual Cost
Administration									
20B 15835	Re-hinge / relocate door to provide needed maneuvering clearance on the latch pull side of the door. ICC / ANSI 404.2.3, Table 404.2.3.1 <i>The poles currently obstruct maneuvering clearance at the door to the administration offices. Photo 3.</i>	1	\$400	\$400	4				
20P 15840	Lower the window in the door (or the sidelite) so the bottom is at 43" maximum. ICC / ANSI 404.2.10 <i>Currently at 55".</i>	1	\$250	\$250	4				
				<i>Location Subtotal:</i>	\$650				
Administration- Storage									
20A 15837	Widen door opening to provide a minimum 32" clear opening. ICC / ANSI 404.2.2 <i>Currently 29".</i>	1	\$1,500	\$1,500	4				
Break Room									
20P 15834	Lower the window in the door (or the sidelite) so the bottom is at 43" maximum. ICC / ANSI 404.2.10 <i>Currently at 55".</i>	1	\$250	\$250	4

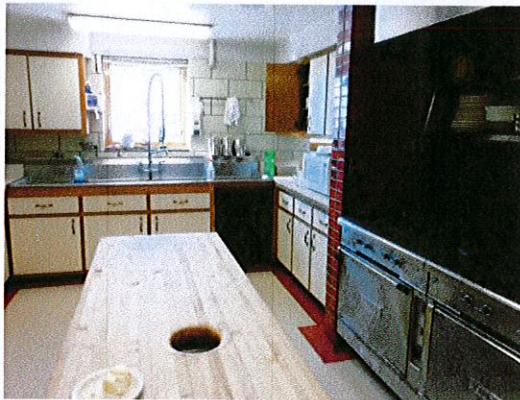
Photo 4: View of kitchen. There are currently no features of accessibility provided. (Commercial appliances are provided, but this is not a commercial kitchen.)

Location JQP # / Item #	Solution / Comments	Qty	Unit Cost	Total Cost	Priority	Estimated Compl. Date	Person Responsible	Actual Compl. Date	Actual Cost
Kitchen									
25J9 15833	Create an accessible kitchen, including: roll under work surface, roll under sink, range with front or side controls, and compliant clearances. ANSI 804 <i>Photo 4.</i>	1	\$7,000	\$7,000	4				
Locker Room									
24 15832	Provide a fully compliant unisex toilet/shower room. IBC 1109.2 <i>The locker room provides 5 toilets, 3 urinals and a multi-fixture shower. There are currently no features of accessibility provided. Photo 5.</i>	1	\$20,000	\$20,000	4				
Lower Level- Gym									
20P 15853	Lower the window in the door (or the sidelite) so the bottom is at 43" maximum. ICC / ANSI 404.2.10 <i>Currently at 50 1/2".</i>	1	\$250	\$250	4				
Lower Level- Locker Room									
24 15852	Provide a fully compliant unisex toilet/shower room. IBC 1109.2	1	\$20,000	\$20,000	4

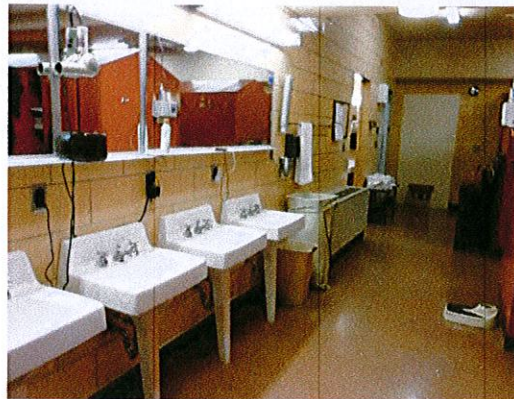
Photo 5: View of locker room. Currently no features of accessibility are provided.

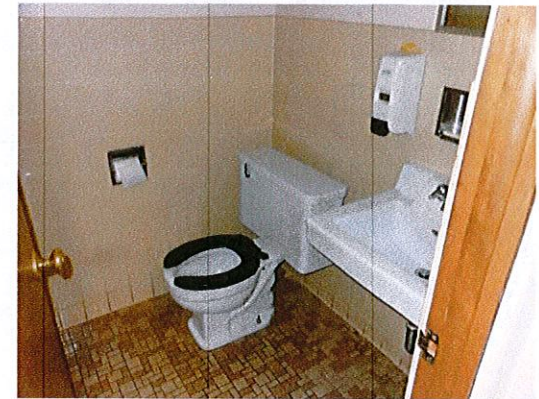
Photo 6: View of single user toilet room on main level. An accessible toilet room is not provided in the fire hall portion of the building.

Location JQP # / Item #	Solution / Comments	Qty	Unit Cost	Total Cost	Priority	Estimated Compl. Date	Person Responsible	Actual Compl. Date	Actual Cost
Single User Toilet Room- Main Level (adjacent to main entry)									
22	15844 Enlarge and upgrade the toilet room to be fully accessible. IBC 1109.2 <i>Photo 6.</i>	1	\$2,000	\$2,000	4				
Single user Toilet Room- Upper Level (private sleeping room)									
24	15838 Provide a fully compliant unisex toilet/shower room. IBC 1109.2	1	\$20,000	\$20,000	4				
Single User Toilet Room- Upper Level (top of stairs)									
22	15830 Enlarge and upgrade the toilet room to be fully accessible. IBC 1109.2	1	\$10,000	\$10,000	4				
Women's Locker Room									
24	15839 Provide a fully compliant unisex toilet/shower room. IBC 1109.2 <i>The women's locker room provides 1 toilet and 2 showers. There are currently no features of accessibility provided.</i>	1	\$20,000	\$20,000	4
