City Hall

Accessibility Review

Transition Plan - (location/priority)

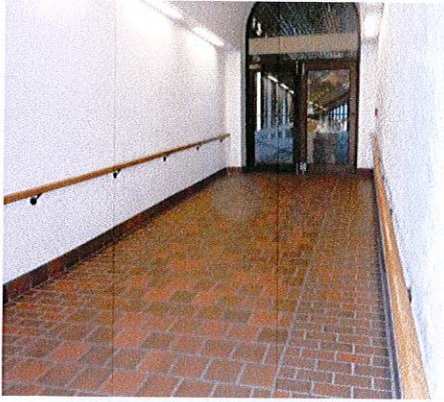
Skyway									
20B0 16928	Install an automatic door opener to address non-compliant maneuvering clearance at the door. (Note: Automatic door opener is not required) ICC / ANSI 404.2.3, Table 404.2.3.1 <i>There is not currently a level landing at the skyway doors. Add automatic doors. JQP, Inc. recommends a motion sensor, there is not a location for a button activated door due to the slope. Photo 1.</i>	1	\$2,000	\$2,000	2

Photo 1: View of skyway entry. There is not a level floor surface for the maneuvering clearance at the doors.

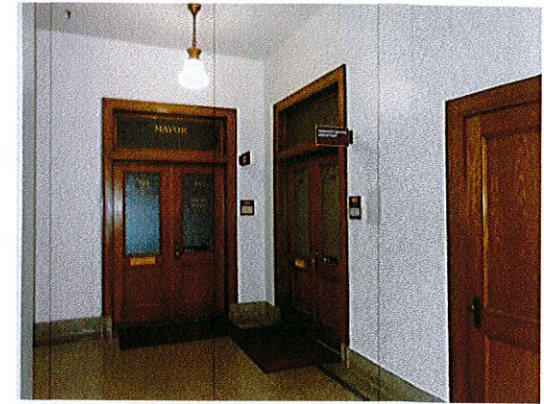
There are typically double doors into each of the departments from the main corridor. Currently a single leaf of the double doors provides a 27" clear opening. Modify the double doors to provide a single leaf with a 32" clear opening (options include a double door with 1 wide leaf and 1 narrow leaf or providing a single door with an sidelite).

Photo 3: Typical corridor doors are narrow double doors (a single leaf provides a 27" clear opening vs. 32" min) with knob style hardware.

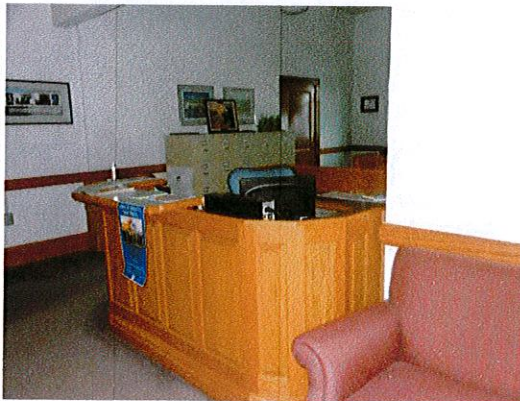
Location JQP # / Item #	Solution / Comments	Qty	Unit Cost	Total Cost	Priority	Estimated Compl. Date	Person Responsible	Actual Compl. Date	Actual Cost
407- Community Development									
20A1 16820	Modify widths of double doors (1 large/1small) to provide a single leaf with a minimum 32" clear opening. ICC / ANSI 404.2.2 <i>A single leaf of the double doors curently provides a 27" clear opening.</i>	1	\$1,500	\$1,500	3				
410- City Attorney									
14G1 16816	Eliminate protruding hazard by installing end panels or other object to direct a person with visual impairments using proper cane technique around the potential hazard. ICC / ANSI 307.1 <i>The in-box currently protrudes 15" at a height of 48".</i>	1	\$200	\$200	3				
21A1 16817	Lower a minimum 36" wide section of counter to a maximum height of 36" above the floor. ICC ANSI 904.3 <i>Currently at 40". Photo 4.</i>	1	\$1,000	\$1,000	3				
				<i>Location Subtotal:</i>					\$1,200

Photo 4: Typical reception counters are at 40" throughout the building (vs. 36" maximum).

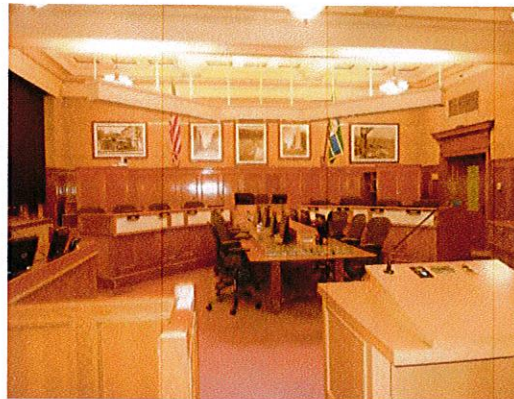
Photo 5: View of council chambers. The council member seating area is raised, a ramp is provided form the corridor doors.

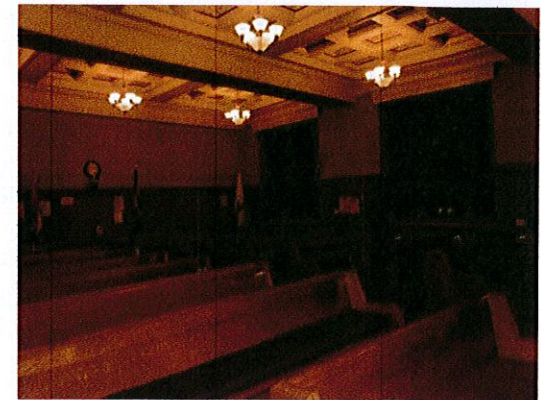
Location JQP # / Item #	Solution / Comments	Qty	Unit Cost	Total Cost	Priority	Estimated Compl. Date	Person Responsible	Actual Compl. Date	Actual Cost
15- Break Room									
20A1 16943	Modify widths of double doors (1 large/1small) to provide a single leaf with a minimum 32" clear opening. ICC / ANSI 404.2.2	1	\$1,500	\$1,500	2				
302- Council Chambers									
20A1 16857	Modify widths of double doors (1 large/1small) to provide a single leaf with a minimum 32" clear opening. ICC / ANSI 404.2.2 <i>A single leaf currently provides a 27 1/2" clear opening.</i>	1	\$1,500	\$1,500	2				
26B 16858	Provide a portable assistive listening system with signage. IBC 1108.2.6	1	\$1,200	\$1,200	2				
26D1 16860	Identify accessible viewing positions. IBC Table 1108.2.2.1 <i>There is currently 1 space designated as accessible. For a seating capacity of 101-300, a minimum of 5 wheelchair positions are required. Photo 6.</i>	1	\$0	\$0	2

Photo 6: View of council chambers seating area. There is currently 1 wheelchair position. Modify the bench seating to provide additional wheelchair positions (that do not obstruct egress routes).

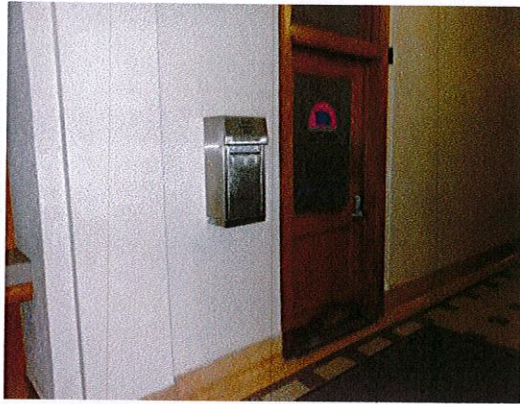
Parking Enforcement									
14F 16962	Lower object(s) so the highest operable part is no higher than 48". ICC / ANSI 308 <i>The slot of the pay box is currently at 56". Photo 7.</i>	1	\$50	\$50	3				
14G2 16963	Remove, relocate or replace object so it is not a protruding object for persons with visual impairments. ICC / ANSI 307.1 <i>The pay box currently protrudes 8" at a height of 41". (Cost already calculated.) Photo 7.</i>	1	\$0	\$0	3

Photo 7: Relocate and lower the pay box on ground floor. It is currently a protruding hazard and the pay slot is located above the reach range.

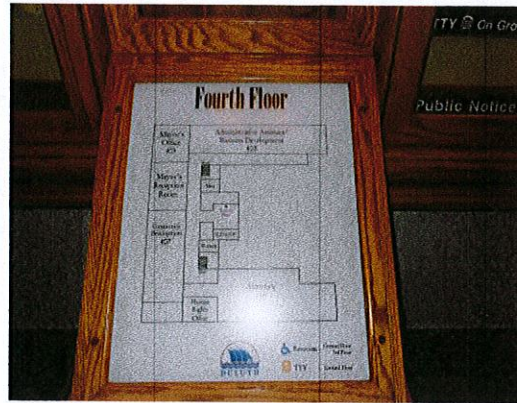
Photo 8: The map opposite the elevator indicates the location of accessibility features (toilet rooms, TTY). *This is a good example of accessibility.*

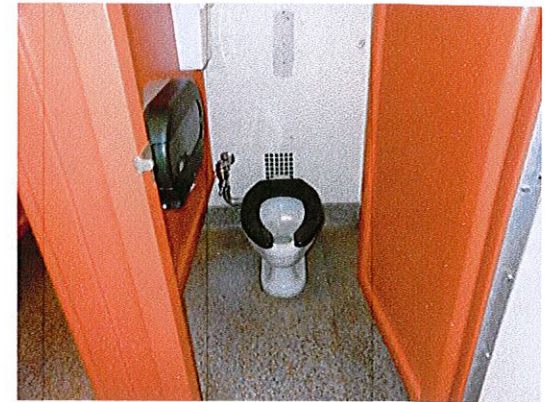
Location JQP # / Item #	Solution / Comments	Qty	Unit Cost	Total Cost	Priority	Estimated Compl. Date	Person Responsible	Actual Compl. Date	Actual Cost
Women's Toilet Room- 1st Floor									
22A2 16914	Install directional signage to the nearest accessible toilet room. MN 1341 1110.2, 1113.10.3.3 <i>Direct to the 3rd floor unisex toilet room.</i>	1	\$50	\$50	1				
Women's Toilet Room- 2nd Floor									
22A2 16878	Install directional signage to the nearest accessible toilet room. MN 1341 1110.2, 1113.10.3.3 <i>Direct to the 3rd floor unisex toilet room.</i>	1	\$50	\$50	1				
Women's Toilet Room- 3rd Floor									
22A2 16839	Install directional signage to the nearest accessible toilet room. MN 1341 1110.2, 1113.10.3.3 <i>Direct to the unisex toilet room on 3rd floor.</i>	1	\$50	\$50	1				
Women's Toilet Room- 4th Floor									
22A2 16806	Install directional signage to the nearest accessible toilet room. MN 1341 1110.2, 1113.10.3.3 <i>Direct to the 3rd floor unisex toilet room. Photo 9.</i>	1	\$50	\$50	1

Photo 9: View of typical women's toilet room. Features of accessibility are not provided in the multi-fixture toilet rooms. Post signs directing to the unisex accessible toilet room.

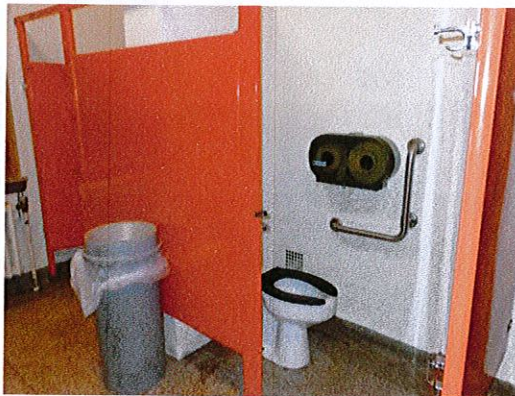
Location JQP # / Item #	Solution / Comments	Qty	Unit Cost	Total Cost	Priority	Estimated Compl. Date	Person Responsible	Actual Compl. Date	Actual Cost
Men's Toilet Room- 1st Floor									
22A2 16907	Install directional signage to the nearest accessible toilet room. MN 1341 1110.2, 1113.10.3.3 <i>Direct to the 3rd floor unisex toilet room.</i>	1	\$50	\$50	1				
Men's Toilet Room- 2nd Floor									
22A2 16900	Install directional signage to the nearest accessible toilet room. MN 1341 1110.2, 1113.10.3.3 <i>Direct to the 3rd floor unisex toilet room.</i>	1	\$50	\$50	1				
Men's Toilet Room- 3rd Floor									
22A2 16870	Install directional signage to the nearest accessible toilet room. MN 1341 1110.2, 1113.10.3.3 <i>Direct to the 3rd floor unisex toilet room.</i>	1	\$50	\$50	1				
Men's Toilet Room- 4th Floor									
22A2 16833	Install directional signage to the nearest accessible toilet room. MN 1341 1110.2, 1113.10.3.3 <i>Direct to the 3rd floor unisex toilet room. Photo 10.</i>	1	\$50	\$50	1

Photo 10: View of typical men's toilet room. Features of accessibility are not provided in the multi-fixture toilet rooms. Post signs directing to the unisex accessible toilet room.

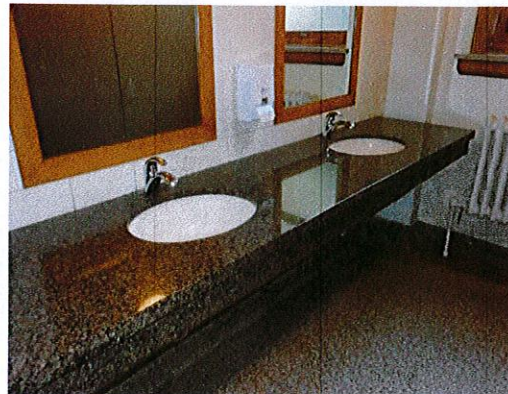
Photo 11: Remodeling in the 1st and 2nd floor toilet rooms incorporated accessibility- such as providing sinks with knee and toe clearance and easily operable faucet hardware. *This is a good example of accessibility.*

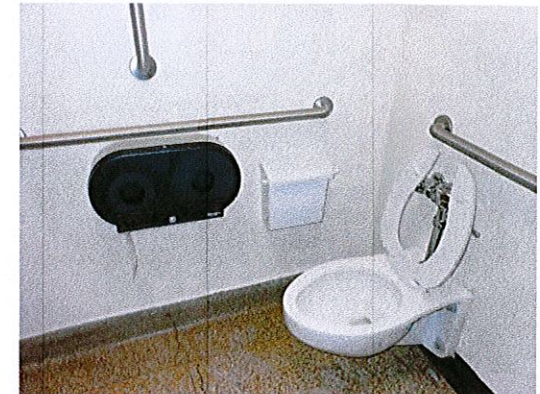
Photo 12: An accessible single user toilet room has been created on 3rd floor. *This is a good example of accessibility.*
