Duluth Heights Community Club

Accessibility Review

Transition Plan - (location/priority)

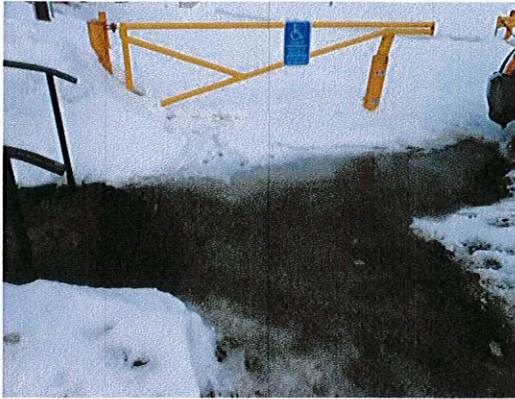
Photo 1: An accessible parking space has been designated near the building. There is currently slope within the parking space causing water and ice to build up.

Parking									
05N 16398	Alter the slope of the accessible parking stall and / or access aisle to be no greater than 1:48 (2%) in any direction. ICC / ANSI 502.5 <i>There is currently a slope exceeding 2% near the head end of the accessible parking spaces, causing flooding and ice build-up. Photo 1.</i>	1	\$500	\$500	4				
Women's Toilet Room- Lower Level									
22-20A 16388	Widen door opening to provide a minimum 32" clear opening. ICC / ANSI 404.2.2 <i>Currently provides 27" clear opening. (There is no door.)</i>	1	\$1,500	\$1,500	4

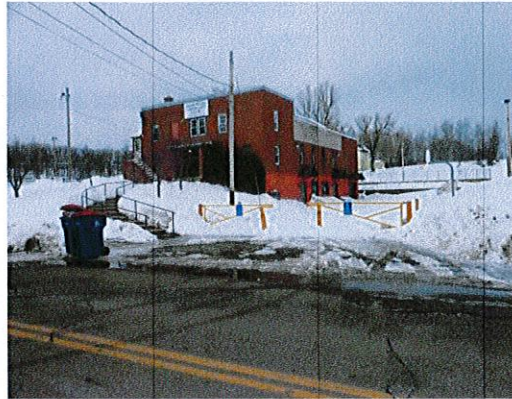
Photo 2: There is not currently an interior accessible route between levels. An on-grade entry is provided to the upper and lower levels. (There is not currently a route to the 3rd floor former apartment.)

Location JQP # / Item #	Solution / Comments	Qty	Unit Cost	Total Cost	Priority	Estimated Compl. Date	Person Responsible	Actual Compl. Date	Actual Cost
Concessions- Lower Level									
27B 16386	Modify / replace sink and / or counter so rim is no higher than 34". ICC / ANSI 606.3 <i>Currently at 36".</i>	1	\$1,000	\$1,000	4				
Drinking Fountain									
41A1 16390	Provide a minimum of one drinking fountain that has a 36" spout height accessible for persons using wheelchairs (low) and one standard height (high) drinking fountain with a spout height 38" minimum and 43" maximum for persons who have difficulty bending or stooping. ANSI 602.4 <i>There is currently 1 drinking fountain at 36".</i>	1	\$1,500	\$1,500	4				
Duluth Heights									
14D1 16400	Provide a fully compliant elevator to provide access between levels. MN 1341 1104.4 and 402.2 <i>There is not currently an interior accessible route between the levels. (On-grade entries are provided to the upper and lower levels.) There is minimal program interaction between the upper and lower levels; no action recommended at this time. Photo 2.</i>	1	\$0	\$0	4

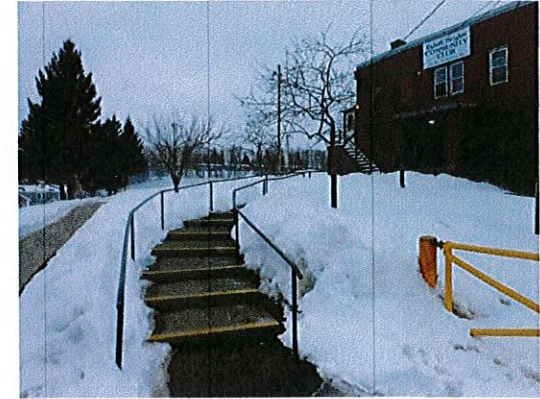
Photo 3: An accessible route to a side entry is provided adjacent to the stairs leading to the upper level.

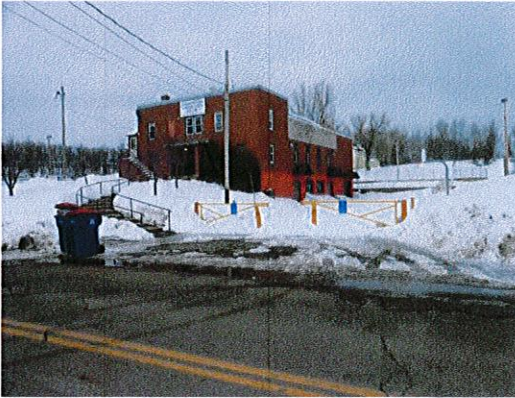
Photo 4: Reconfigure the accessible parking. If a vehicle were in the space on the right it would block access to the route to the upper level.

Location JQP # / Item #	Solution / Comments	Qty	Unit Cost	Total Cost	Priority	Estimated Compl. Date	Person Responsible	Actual Compl. Date	Actual Cost
Parking									
16399	<i>Relocate the accessible parking spaces, they currently block the route to the building. Photo 4.</i>	1	\$0	\$0	2				
				Priority # 2 Total	\$0

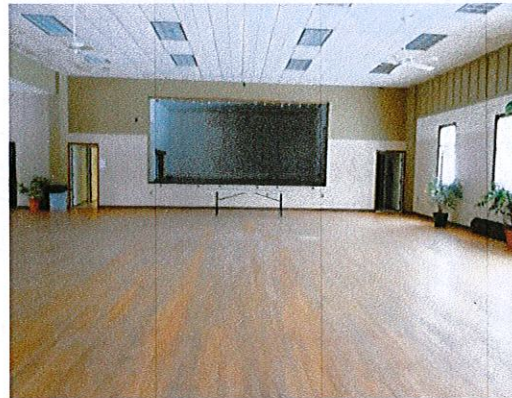
Photo 5: View of main room and stage. There is not currently an accessible route to the stage.

Location JQP # / Item #	Solution / Comments	Qty	Unit Cost	Total Cost	Priority	Estimated Compl. Date	Person Responsible	Actual Compl. Date	Actual Cost
Stage									
14D4 16370	Provide a compliant ramp at change in level. MN 1341 402.2 <i>There is currently a 34" rise at the stage. Photo 5.</i>	1	\$5,000	\$5,000	3				
Women's Toilet Room- Lower Level									
22.1 16389	Upgrade toilet room to be fully accessible. IBC 1109.2 <i>Photo 11.</i>	1	\$10,000	\$10,000	3				
22B 16387	Install signage with appropriate raised and Braille lettering. MN 1341 1110.2	1	\$40	\$40	3				
				<i>Location Subtotal:</i>					\$10,040

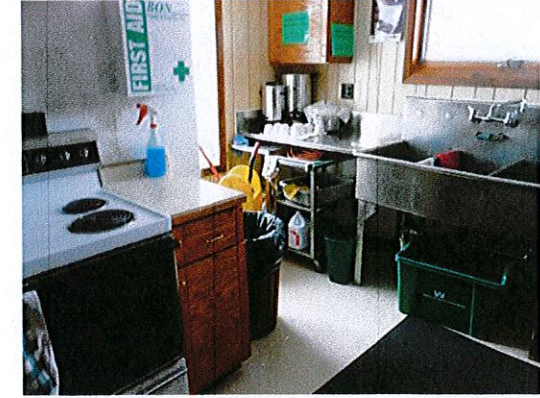
Photo 6: View of kitchen. There are currently no features of accessibility provided.

Location JQP # / Item #	Solution / Comments	Qty	Unit Cost	Total Cost	Priority	Estimated Compl. Date	Person Responsible	Actual Compl. Date	Actual Cost
Kitchen- Upper Level									
25J9 16360	Create an accessible kitchen, including: roll under work surface, roll under sink, range with front or side controls, and compliant clearances. ANSI 804 <i>There is a full kitchen, it currently provides no features of accessibility. Photo 6.</i>	1	\$7,000	\$7,000	4				
Men's Toilet Room- Lower Level									
22-20A 16393	Widen door opening to provide a minimum 32" clear opening. ICC / ANSI 404.2.2 <i>Currently provides 27" clear opening. (There is no door.)</i>	1	\$1,500	\$1,500	4				
Men's Toilet Room- Upper Level									
22-20B 16362	Re-hinge / relocate door to provide needed maneuvering clearance on the latch pull side of the door. ICC / ANSI 404.2.3, Table 404.2.3.1 <i>Currently provides 4" at the corridor from the main room. Photo 7.</i>	1	\$750	\$750	4

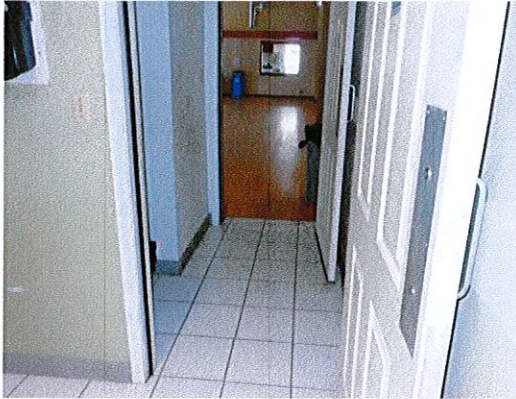
Photo 7: Maneuvering clearance is not currently provided at the entry doors to the upper level toilet rooms.

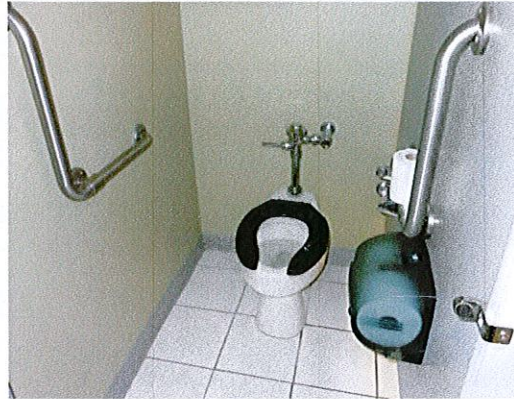
Photo 8: The upper level toilet rooms have been remodeled to provide an ambulatory accessible stall. There is not currently a 60" wide stall.

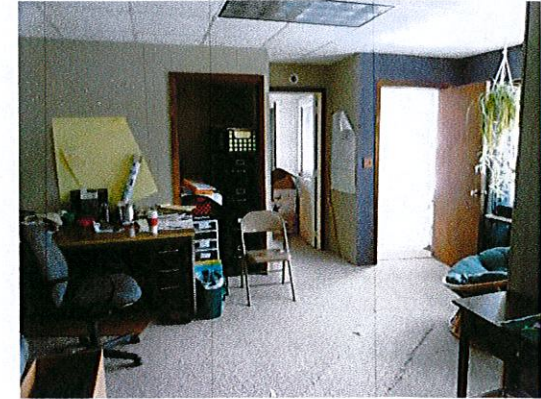
Photo 9: The apartment is now used by the community club. There is not currently an accessible route and there are no features of accessibility provided at the kitchen or bathroom.

Former Apartment									
24 16384	Provide a fully compliant unisex toilet/shower room. IBC 1109.2	1	\$20,000	\$20,000	4				
25J9 16383	Create an accessible kitchen, including: roll under work surface, roll under sink, range with front or side controls, and compliant clearances. ANSI 804	1	\$7,000	\$7,000	4				
				<i>Location Subtotal:</i>	\$27,000

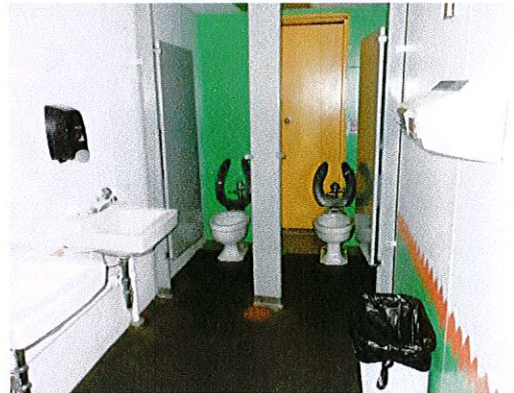
Photo 11: The lower level toilet rooms currently provide no features of accessibility.

22.1 16394	Upgrade toilet room to be fully accessible. IBC 1109.2 <i>Photo 11.</i>	1	\$10,000	\$10,000	3				
22B 16392	Install signage with appropriate raised and Braille lettering. MN 1341 1110.2	1	\$40	\$40	3				
				<i>Location Subtotal:</i>					\$10,040
