Lower Chester Community Club

Accessibility Review

Lower Chester Park Community Club

City of Duluth, MN

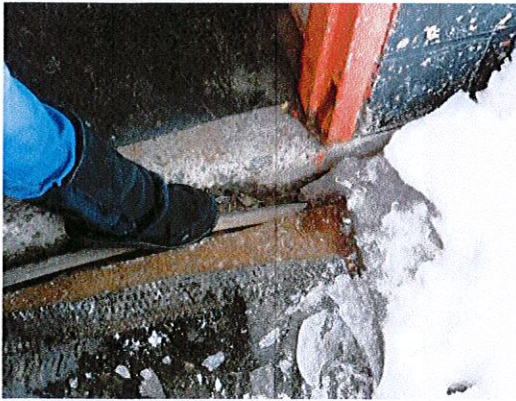
Location JQP # / Item #	Solution / Comments	Qty	Unit Cost	Total Cost	Priority	Estimated Compl. Date	Person Responsible	Actual Compl. Date	Actual Cost
NE Entry									
12D	16289 Provide door hardware that does not require grasping, pinching or twisting to operate, such as lever. Exterior security hardware. ICC / ANSI 404.2.6	1	\$325	\$325	2				
12H	16971 Bevel / replace / reset threshold so there is no abrupt rise greater than 1/2" or slope greater than 1:2. ICC / ANSI 404.2.4 Photo 1.	1	\$200	\$200	2				
				<i>Location Subtotal:</i>					\$525
				Priority # 2 Total					\$525

Photo 1: Patch the rise at the main entry.

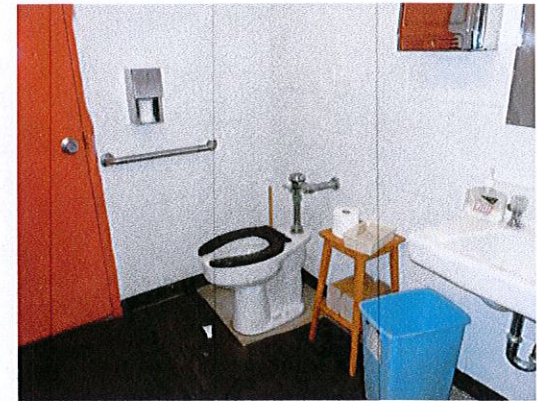
Photo 3: The women's toilet room is large enough to provide accessibility. Convert this to a single-user accessible toilet room.

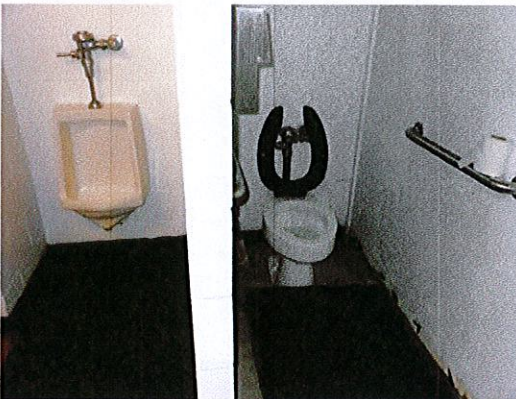
Location JQP # / Item #	Solution / Comments	Qty	Unit Cost	Total Cost	Priority	Estimated Compl. Date	Person Responsible	Actual Compl. Date	Actual Cost
Concessions									
27B 16307	Modify / replace sink and / or counter so rim is no higher than 34". ICC / ANSI 606.3 <i>Currently at 36".</i>	1	\$1,000	\$1,000	4				
Furnace Room									
20D 16291	Provide door hardware that does not require grasping, pinching or twisting to operate, such as lever. ICC / ANSI 404.2.6	1	\$250	\$250	4				
Hose Room									
20B 16288	Re-hinge / relocate door to provide needed maneuvering clearance on the latch pull side of the door. ICC / ANSI 404.2.3, Table 404.2.3.1 <i>Currently provides 11".</i>	1	\$400	\$400	4				
Men's Toilet Room									
22D 16303	Remove interior partitions to create a single use toilet room. It is recommended that a privacy lock be installed. ICC / ANSI 603.2 <i>Photo 4.</i>	1	\$1,500	\$1,500	4

Photo 4: The men's toilet room does not currently provide any features of accessibility.

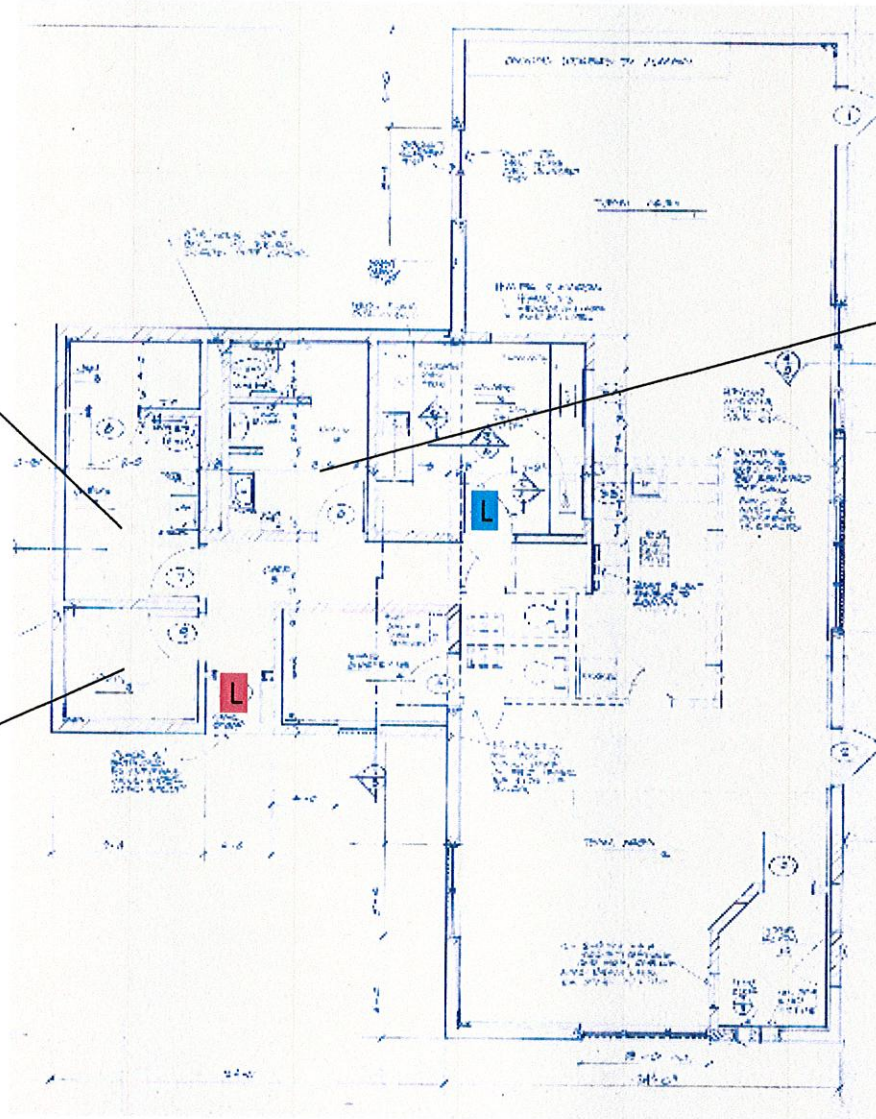
Add raised and braille sign
 Replace faucet
 Replace grab bars
 Add full height mirror
 Remove door closer

Add raised and braille sign
 Replace faucet
 Lower towel dispenser
 Relocate toilet paper dispenser
 Replace grab bars

Add raised and braille sign
