Woodland Recreation / Community Club

Accessibility Review

Transition Plan - (location/priority)

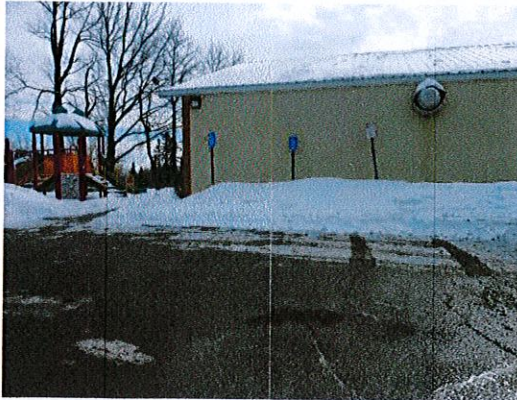
| Location JQP # / Item # | Solution / Comments | Qty | Unit Cost | Total Cost | Priority | Estimated Compl. Date | Person Responsible | Actual Compl. Date | Actual Cost |
|---|---|---|---|---|---|---|---|---|---|
| 05A 15624 | Stripe an appropriate number of accessible parking stalls and provide appropriate permanent signage. IBC 1106.1 <i>There are currently 2 spaces designated as accessible near the Woodland Recreation Center Entry. This parking lot is shared with Fryberger Arena. Photo 1.</i> | 1 | \$400 | \$400 | 3 | | | | |

Photo 1: View of parking. There are 2 spaces designated as accessible near the rec center entry. (The lot is shared with Fryberger Arena.)

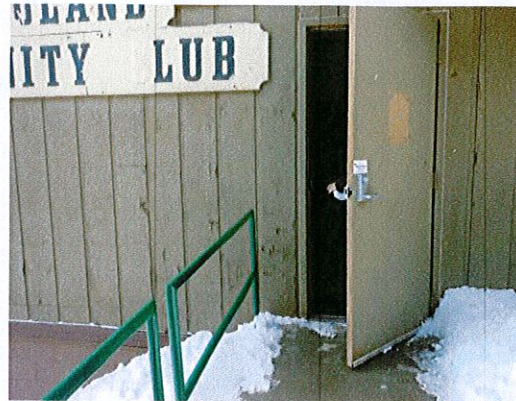
| Location | Solution / Comments | Qty | Unit Cost | Total Cost | Priority | Estimated Compl. Date | Person Responsible | Actual Compl. Date | Actual Cost |
|--|--|---|---|---|---|---|---|---|---|
| 12B1 | 15611 Extend sidewalk to provide appropriate maneuvering clearance on the latch side of the door. ICC / ANSI 404.2.3.1 <i>Currently provides 13". Photo 2.</i> | 1 | \$500 | \$500 | 2 | | | | |

Photo 2: Enlarge the concrete pad to provide maneuvering clearance at the community room entry.

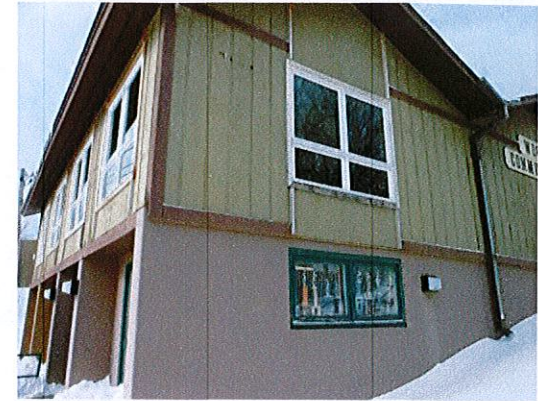
| Location JQP # / Item # | Solution / Comments | Qty | Unit Cost | Total Cost | Priority | Estimated Compl. Date | Person Responsible | Actual Compl. Date | Actual Cost |
|---|---|---|---|---|---|---|---|---|---|
| 14D1 15618 | Provide a fully compliant elevator to provide access between levels. MN 1341 1104.4 and 402.2 <i>There is not currently an accessible route between the upper level and lower level warming house. The upper level community room is used as a player and family lounge. Photo 3.</i> | 1 | \$250,000 | \$250,000 | 3 | | | | |

Photo 3: The WAHA uses the upper level community room as a lounge. There is not currently an accessible route between the upper and lower (warming house) level.

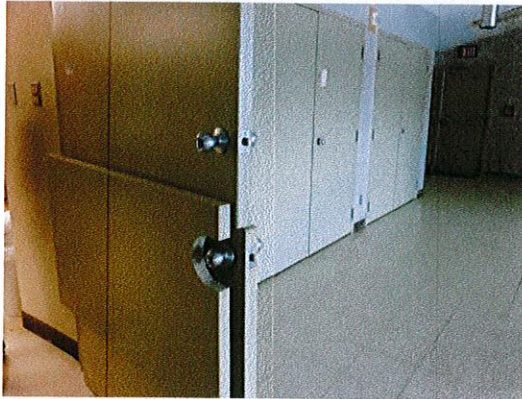
| Location JQP # / Item # | Solution / Comments | Qty | Unit Cost | Total Cost | Priority | Estimated Compl. Date | Person Responsible | Actual Compl. Date | Actual Cost |
|--|---|---|---|---|---|---|---|---|---|
| 20D 15608 | Provide door hardware that does not require grasping, pinching or twisting to operate, such as lever. ICC / ANSI 404.2.6 <i>Photo 4.</i> | 4 | \$250 | \$1,000 | 3 | | | | |

Photo 4: Typical hardware throughout the building is knob style. Replace the knob with a style that does not require grasping, pinching or twisting to operate (such as a lever).

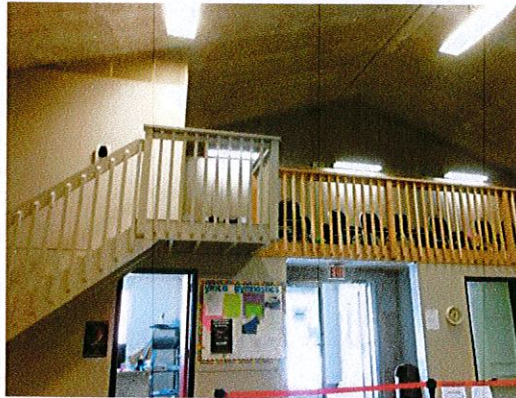
| Location | Solution / Comments | Qty | Unit Cost | Total Cost | Priority | Estimated Compl. Date | Person Responsible | Actual Compl. Date | Actual Cost |
|---|---|---|---|---|---|---|---|---|---|
| 14D2 15617 | Relocate program as necessary to an accessible location to provide program access. MN 1341 1104.4 <i>There is not currently an accessible route to the viewing balcony. Identify a location on an accessible route for a wheelchair position that will allow viewing of the various events. Photos 5 and 6.</i> | 1 | \$0 | \$0 | 1 | | | | |

Photo 5: A small viewing loft is provided in the gymnastics area. There is not currently an accessible route. Add handrails at the stairs.

| Location JQP # / Item # | Solution / Comments | Qty | Unit Cost | Total Cost | Priority | Estimated Compl. Date | Person Responsible | Actual Compl. Date | Actual Cost |
|--|--|---|---|---|---|---|---|---|---|
| 16A 15616 | Install fully compliant handrails on both sides of the stairs. ANSI 504.6 | 60 | \$25 | \$1,500 | 4 | | | | |

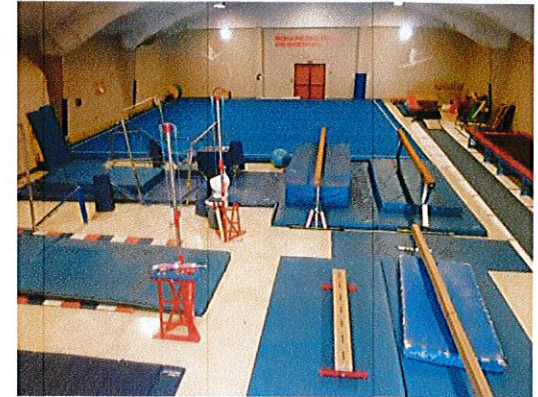
Photo 6: Create wheelchair viewing positions on the gymnastics floor (because there is not an accessible route to the viewing loft).

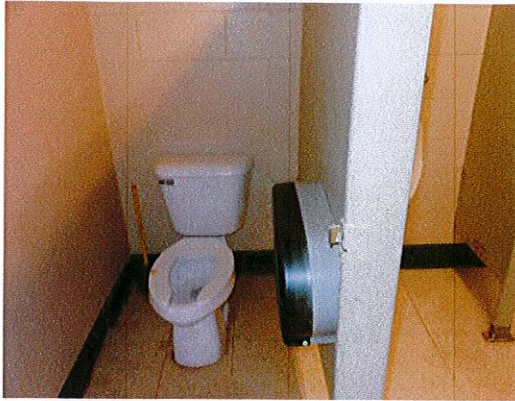
| Location | Solution / Comments | Qty | Unit Cost | Total Cost | Priority | Estimated Compl. Date | Person Responsible | Actual Compl. Date | Actual Cost |
|--|--|---|---|---|---|---|---|---|---|
| 22.1 | 15612 Upgrade toilet room to be fully accessible. IBC 1109.2 <i>JQP, Inc. reviewed proposed plans to remodel this toilet room to provide features of accessibility. Photo 7.</i> | 1 | \$10,000 | \$10,000 | 2 | | | | |

Photo 7: View of existing upper level toilet room. Remodeling is planned to provide features of accessibility.

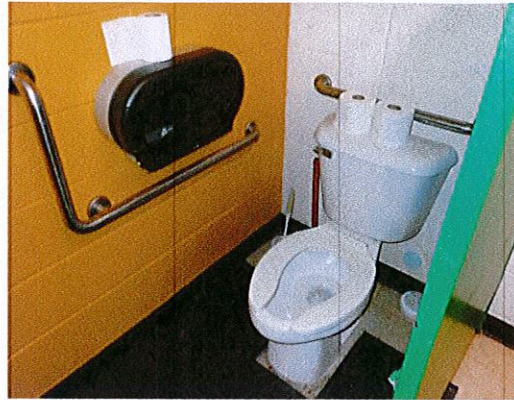
| Location JQP # / Item # | Solution / Comments | Qty | Unit Cost | Total Cost | Priority | Estimated Compl. Date | Person Responsible | Actual Compl. Date | Actual Cost |
|--|---|---|---|---|---|---|---|---|---|
| 22D 15621 | Remove interior partitions to create a single use toilet room. It is recommended that a privacy lock be installed. ICC / ANSI 603.2 <i>Photo 8.</i> | 1 | \$1,500 | \$1,500 | 3 | | | | |

| Location JQP # / Item # | Solution / Comments | Qty | Unit Cost | Total Cost | Priority | Estimated Compl. Date | Person Responsible | Actual Compl. Date | Actual Cost |
|---|---|---|---|---|---|---|---|---|---|
| 22D 15620 | Remove interior partitions to create a single use toilet room. It is recommended that a privacy lock be installed. ICC / ANSI 603.2 <i>Photo 8.</i> | 1 | \$1,500 | \$1,500 | 3 | | | | |

Photo 8: View of lower level toilet room. Currently no features of accessibility are provided.

Remove partitions and create single user

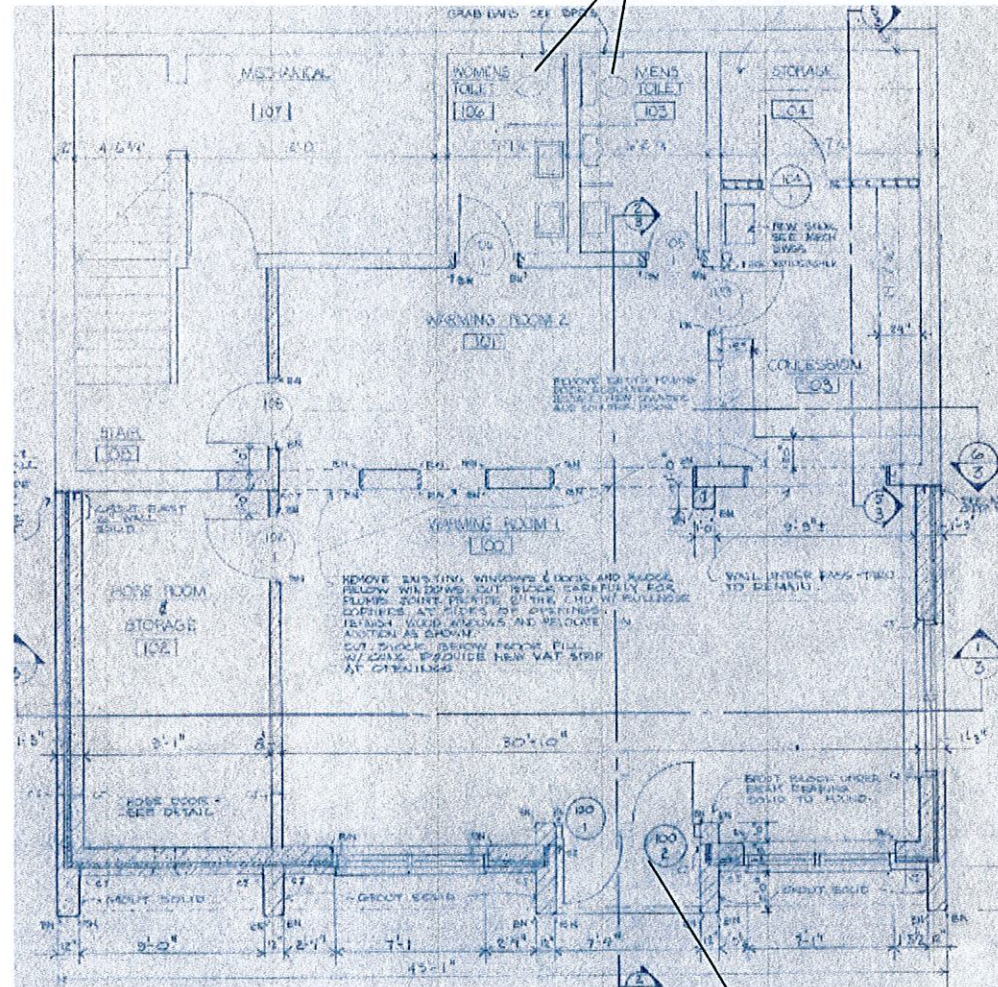
Woodland Recreation / Community Center
Lower Level
City of Duluth, MN

Bevel threshold
