Fryberger Arena

Accessibility Review

Transition Plan - (location/priority)

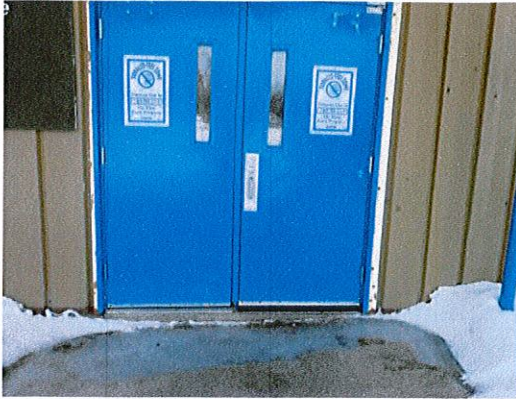
Photo 1: Eliminate the rise at the threshold at the main entry.

Location JQP # / Item #	Solution / Comments	Qty	Unit Cost	Total Cost	Priority	Estimated Compl. Date	Person Responsible	Actual Compl. Date	Actual Cost
Main Entry									
12H 16421	Bevel / replace / reset threshold so there is no abrupt rise greater than 1/2" or slope greater than 1:2. ICC / ANSI 404.2.4 <i>There is currently a 4" rise. Photo 1.</i>	1	\$500	\$500	2				
Single User Toilet Room									
22-20J 16431	Modify or remove partition / wall to provide compliant clear width at a turn. ICC / ANSI 403.5 <i>Remove the privacy partition; it obstructs the maneuvering clearance at the door. Photo 5.</i>	1	\$1,500	\$1,500	2				
22Q 16429	Insulate or otherwise protect exposed pipes at lavatory. ICC / ANSI 606.6 <i>Photo 4.</i>	1	\$50	\$50	2				
				<i>Location Subtotal:</i>					\$1,550
Spectator Seating									
26D 16445	Create wheelchair viewing positions to meet the required number. IBC Table 1108.2.2.1 <i>There are currently no wheelchair viewing positions in the spectator seating area. Based on an approximate seating capacity of 350, a minimum of 6 wheelchair positions are required. Photo 3.</i>	1	\$10,000	\$10,000	2

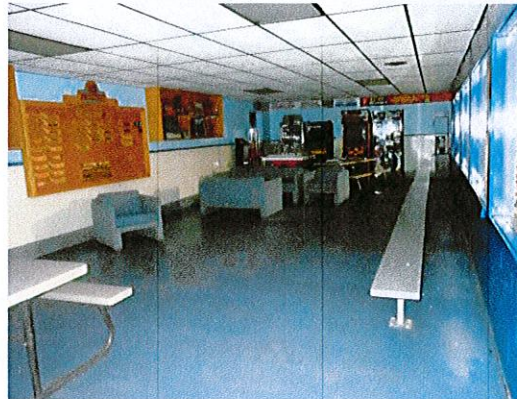
Photo 2: The upper level provides concessions, toilet rooms and a seating/viewing area. There is not currently an accessible route to the upper level.

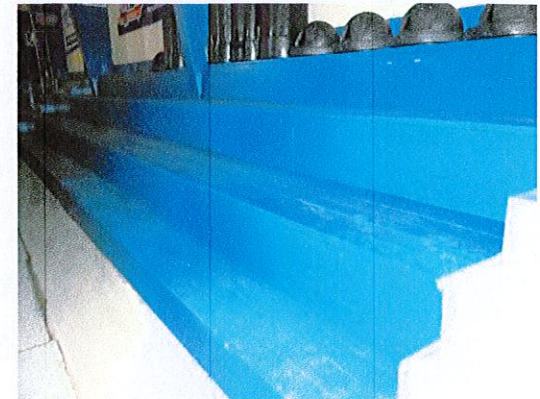
Photo 3: The spectator seating area is not currently located on an accessible route and does not provide wheelchair positions.

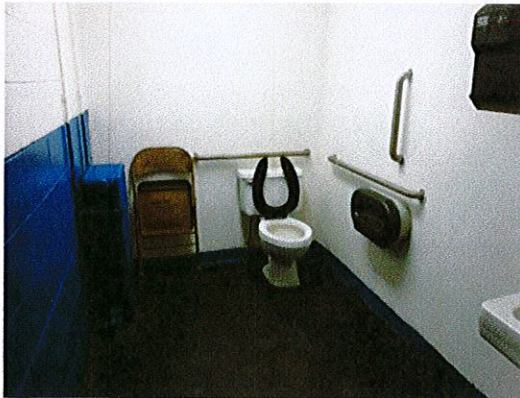
Photo 4: A single user accessible toilet room is provided on the main level. *This is a good example of accessibility.*

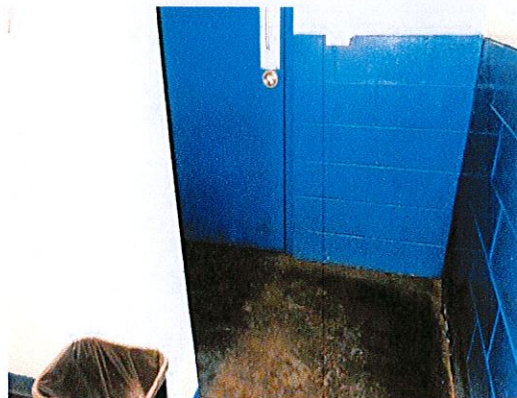
Photo 5: Remove the privacy wall at the single user accessible toilet room (it currently obstructs maneuvering clearance at the door). A privacy lock is already provided.

Location JQP # / Item #	Solution / Comments	Qty	Unit Cost	Total Cost	Priority	Estimated Compl. Date	Person Responsible	Actual Compl. Date	Actual Cost
Single User Toilet Room									
22B1 16430	Relocate compliant sign to the wall adjacent to latch side of door, 48" minimum to the baseline of the lowest Braille characters and 60" maximum to the baseline of the highest tactile character. ICC/ANSI 703.3.10, 703.4.5	1	\$40	\$40	3				
Upper Level									
14D1 16422	Provide a fully compliant elevator to provide access between levels. MN 1341 1104.4 and 402.2 <i>There is not currently an accessible route to the upper level. The upper level provides toilet rooms, concessions and a heated viewing area. Photo 2.</i>	1	\$250,000	\$250,000	3				
20D 16425	Provide door hardware that does not require grasping, pinching or twisting to operate, such as lever. ICC / ANSI 404.2.6	2	\$250	\$500	3				
				<i>Location Subtotal:</i>					\$250,500

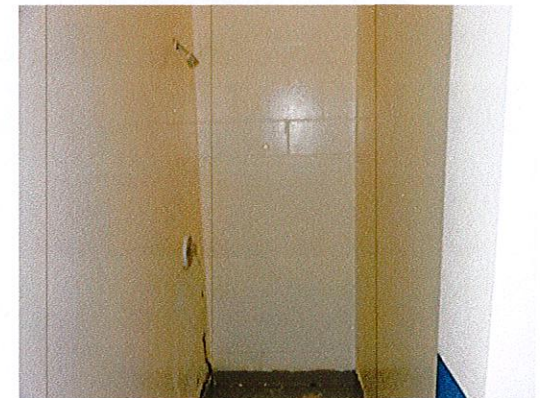
Photo 6: View of team room shower. There are currently no features of accessibility provided.

22.1	16435 Upgrade toilet room to be fully accessible. IBC 1109.2	1	\$10,000	\$10,000	4				
24.1	16436 Provide a fully compliant shower room. IBC 1109.2 <i>Or remove the shower.</i>	1	\$5,000	\$5,000	4				
				<i>Location Subtotal:</i>					\$15,000
Men's Toilet Room- Upper Level
