Lake Superior Zoo

Accessibility Review

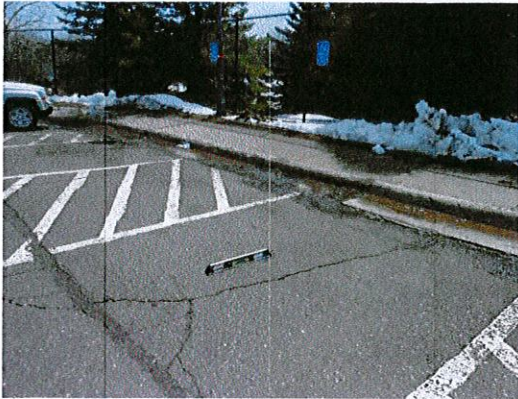
Photo 1: Relocate or modify the accessible parking so the slope does not exceed 2% (currently 6.5%).

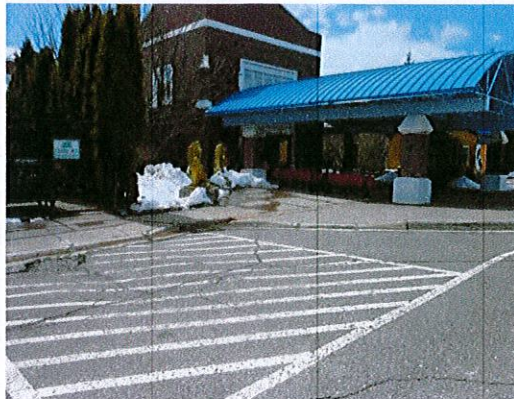
Photo 2: Patch and repair the curb cut.

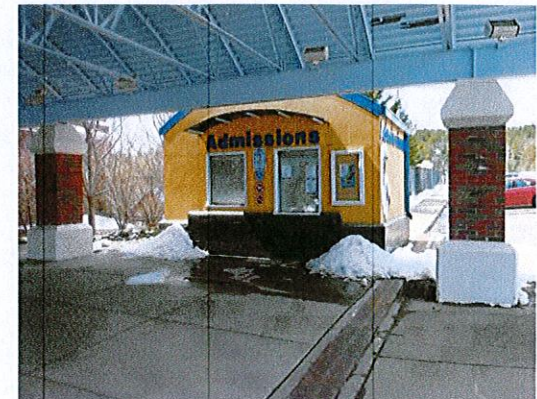
Location JQP # / Item #	Solution / Comments	Qty	Unit Cost	Total Cost	Priority	Estimated Compl. Date	Person Responsible	Actual Compl. Date	Actual Cost
Admission/Ticket Building									
21A1 16747	Lower a minimum 36" wide section of counter to a maximum height of 36" above the floor. ICC ANSI 904.3 <i>Currently at 37". Note: the admission/ticket building is only used seasonally. Ticket sales take place in the main building during the winter. Photo 3.</i>	1	\$1,000	\$1,000	4				
Animal Care Center- Break Room									
27B 16791	Modify / replace sink and / or counter so rim is no higher than 34". ICC / ANSI 606.3 <i>Currently at 36".</i>	1	\$1,000	\$1,000	4				
Animal Care Center- Toilet Rooms									
22B 16792	Install signage with appropriate raised and Braille lettering. MN 1341 1110.2	2	\$40	\$80	4				
Main Building- Drinking Fountain- Lower Level									
41A1 16783	Provide a minimum of one drinking fountain that has a 36" spout height accessible for persons using wheelchairs (low) and one standard height (high) drinking fountain with a spout height 38" minimum and 43" maximum for persons who have difficulty bending or stooping. ANSI 602.4 <i>Currently provides 1 drinking fountain with a spout at 36" and 26" knee clearance.</i>	1	\$1,500	\$1,500	4

Photo 3: The ticket windows at the exterior admission building are currently at 37" (vs. 36" maximum).

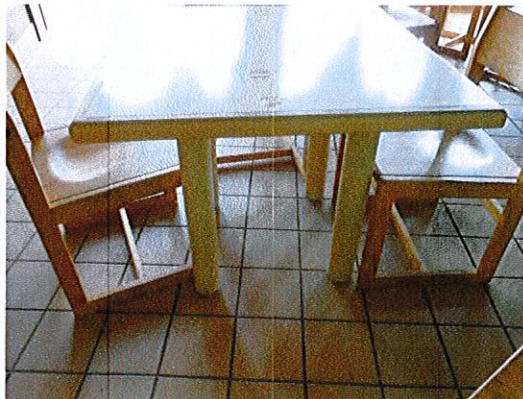
Location JQP # / Item #	Solution / Comments	Qty	Unit Cost	Total Cost	Priority	Estimated Compl. Date	Person Responsible	Actual Compl. Date	Actual Cost
Australian Connection- Route									
08D1 16800	Modify / replace existing surface material to eliminate changes in level greater than 1/2". ANSI 303.2, Figure 303.2 <i>The sidewalk/asphalt is currently damaged along the route to the entry.</i>	1	\$10,000	\$10,000	3				
12B1 16801	Extend sidewalk to provide appropriate maneuvering clearance on the latch side of the door. ICC / ANSI 404.2.3.1 <i>The door leading to/from the 'trail'.</i>	1	\$500	\$500	3				
				<i>Location Subtotal:</i>					\$10,500
Curb Ramp									
07G 16746	Patch lip at the base of the curb cut / ramp so there is no abrupt rise greater than 1/2". ICC / ANSI 303 <i>Photo 2.</i>	1	\$250	\$250	3				
Main Building- Dining									
25E 16748	Provide accessible height table(s) within the cafeteria. IBC 1108.2.8.1 <i>Currently none of the dining tables in the café area provide knee or toe clearance. Photo 4.</i>	1	\$200	\$200	3

Photo 4: Provide a table in the cafe area that provides knee and toe clearance.

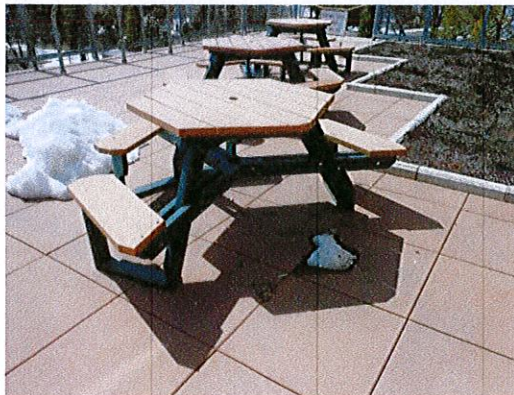
Photo 5: Tables on the deck currently provide positions with knee and toe clearance. *This is a good example of accessibility.*

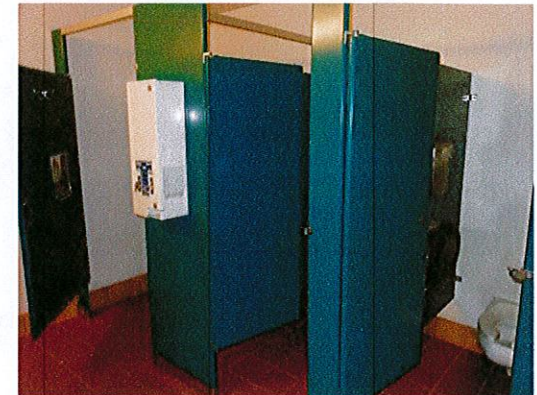
Photo 6: Relocate the product dispenser so it does not create a protruding hazard in the upper level women's toilet room.

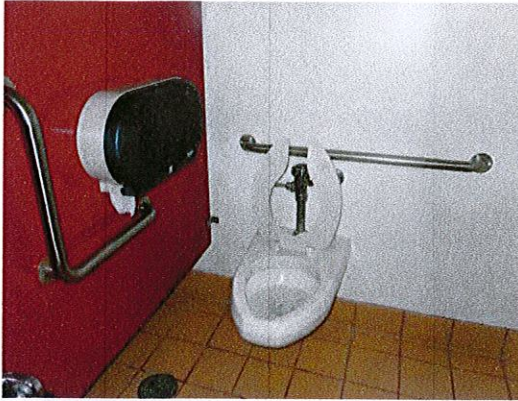
Location JQP # / Item #	Solution / Comments	Qty	Unit Cost	Total Cost	Priority	Estimated Compl. Date	Person Responsible	Actual Compl. Date	Actual Cost
Main Building- Women's Toilet Room- Upper Level									
22-14G1 16757	Relocate / remove protruding object or install recessed model. ICC / ANSI 307.1 <i>The product dispenser currently protrudes 6 1/2" at a height of 39". Photo 6.</i>	1	\$150	\$150	3				
22G (MN) 16750	Modify to provide a minimum clearance of 48" in front of the water closet. MN 1341 604.3.1 <i>Currently provides 32" in front.</i>	1	\$1,000	\$1,000	3				
22H1 16755	Provide staple style pulls on both sides of the accessible stall door near the latch. ANSI 604.8.3	1	\$50	\$50	3				
22K6 (MN) 16751	Remove the existing grab bar configuration and replace with a compliant grab bar configuration. MN 1341 604.5.1 ANSI 604.5.2 <i>Photo 7.</i>	1	\$400	\$400	3				
22L (MN) 16752	Reposition the toilet paper dispenser so it is located below the horizontal grab bar. Operable parts should be located within an area 12" - 40" from the rear wall, and 18" minimum above the floor and 1 1/2" minimum below the horizontal grab bar. MN 1341 604.7 <i>Photo 7.</i>	1	\$50	\$50	3

Photo 7: Some features of accessibility have been provided in the upper level toilet rooms of the main building. Replace the "L" shaped grab bar and relocate the toilet paper dispenser to below the grab bar.

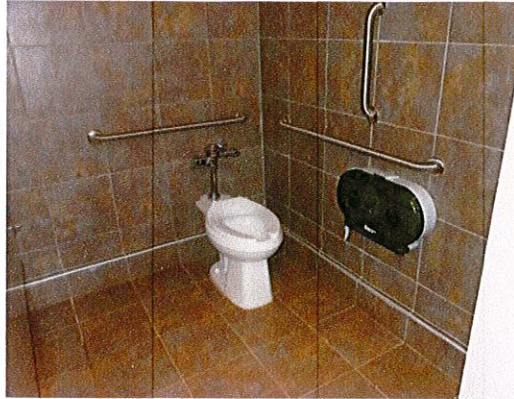
Photo 8: View of lower level toilet in the main building. *This is a good example of accessibility.*

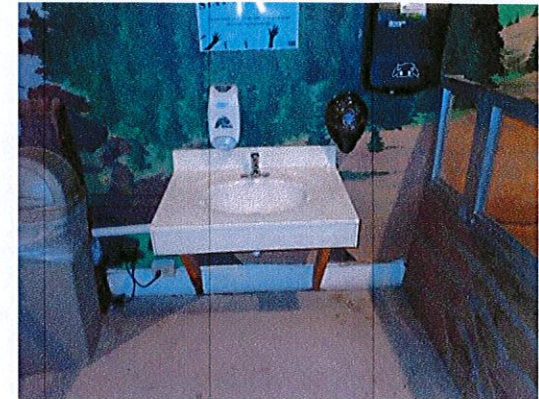
Main Building- Griggs Learning Center									
20D 16769	Provide door hardware that does not require grasping, pinching or twisting to operate, such as lever. ICC / ANSI 404.2.6 <i>Office/Cages</i>	1	\$250	\$250	3				
22P 16770	Raise the lavatory to provide a minimum knee clearance height of 27". ICC / ANSI 606.2 <i>There is currently 1 sink with the top at 27 1/2" and 23" knee clearance. It may be appropriate to provide a 2nd sink at this location at children's standards. Photo 9.</i>	1	\$1,000	\$1,000	3				
				<i>Location Subtotal:</i>					\$1,250

Photo 9: The hand wash sink in the Griggs Learning Center does not currently provide knee and toe clearance. Consider providing 2 sinks at this location, including 1 at children's standards.

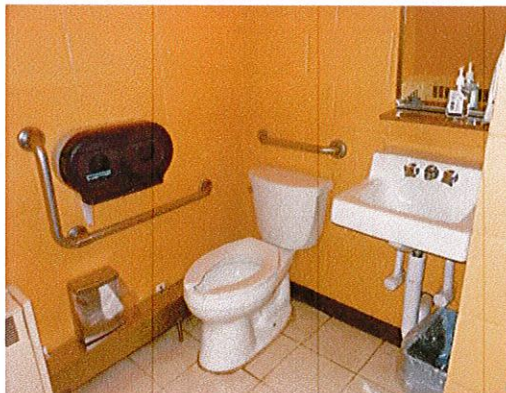
Primate / Nocturnal- Storage									
20D 16785	Provide door hardware that does not require grasping, pinching or twisting to operate, such as lever. ICC / ANSI 404.2.6	2	\$250	\$500	4				
Primate / Nocturnal- Toilet Rooms									
22 16786	Enlarge and upgrade the toilet room to be fully accessible. IBC 1109.2 <i>There are 2 single user toilet rooms that currently provide no features of accessibility. Photo 11.</i>	2	\$10,000	\$20,000	4				
				Priority # 4 Total					\$47,330

Photo 11: View of single user toilet room in Primate / Nocturnal building. This location is not currently accessible.

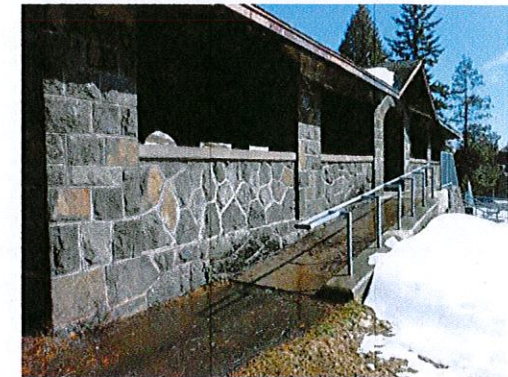
Photo 12: View of picnic pavilion. Add a handrail to the wall side of the ramp.

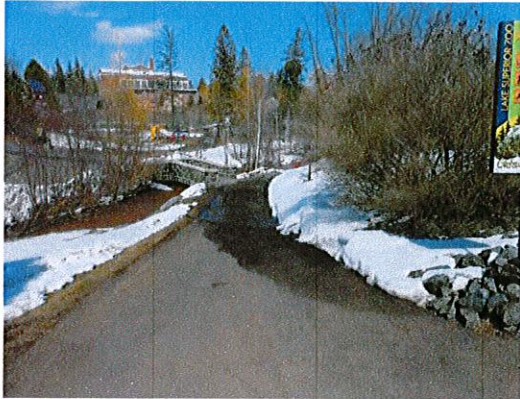
Location JQP # / Item #	Solution / Comments	Qty	Unit Cost	Total Cost	Priority	Estimated Compl. Date	Person Responsible	Actual Compl. Date	Actual Cost
Zoo Grounds									
08A 16802	Provide an accessible route. IBC 1104 <i>The routes throughout the zoo grounds have many segments with slopes that exceed 5% (or exceed 8.33% without handrails). The route is wide enough and provides a firm, stable surface. There are segments of the route that have been damaged/worn and have crumbled away. Photo 13.</i>	1	\$50,000	\$50,000	3				
				Priority # 3 Total	\$98,250

Photo 13: The route through the zoo is steep and rough in multiple locations.

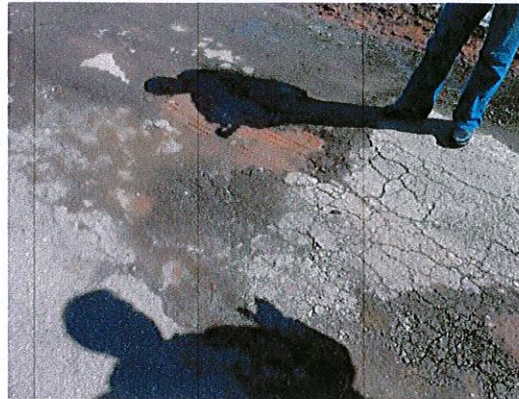
Photo 14: The route through the zoo is steep and rough in multiple locations.
