## **Main Library**

## Library- Main

## Accessibility Review

Transition Plan - (location/priority)

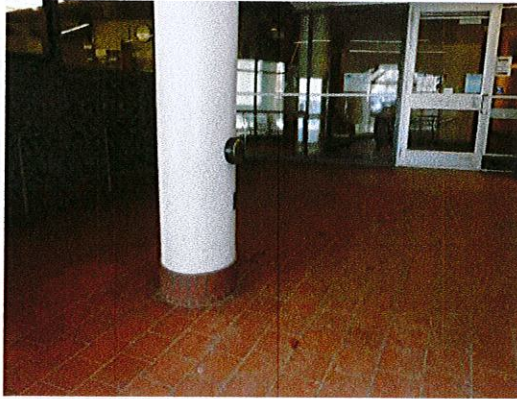
**Photo 1:** Relocate the control button for the power door opener to a location with 1:48 max slope.

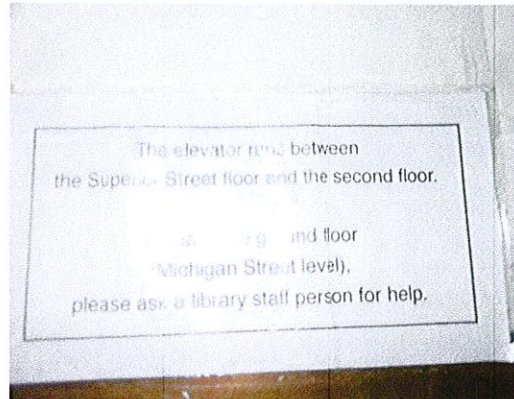
**Photo 2:** Modify policy to allow independent use of the elevator. Currently staff assistance is necessary to reach ground floor (Michigan St).

Location JQP # / Item #	Solution / Comments	Qty	Unit Cost	Total Cost	Priority	Estimated Compl. Date	Person Responsible	Actual Compl. Date	Actual Cost
<b>Elevator</b>									
18N 15699	Modify/replace elevator to allow unassisted entry, operation and exit. MN1341 407.1 <i>Currently staff assistance is required to take the elevator to ground level (Michigan Street) due to security concerns. (There are public spaces located on all levels.) Photo 2.</i>	1	\$100,000	\$100,000	1				
<b>Staff Toilet Room- 2nd Floor</b>									
22D 15720	Remove interior partitions to create a single use toilet room. It is recommended that a privacy lock be installed. ICC / ANSI 603.2 <i>JQP, Inc. recommends converting this location to a public single-user accessible toilet room. Currently no other toilet room in the building provides a toilet with 60" clearance. This location is recommended because: it is not within a secure staff area, it is not designated as 'children only' and there is only 1 fixture.</i>	1	\$1,500	\$1,500	1

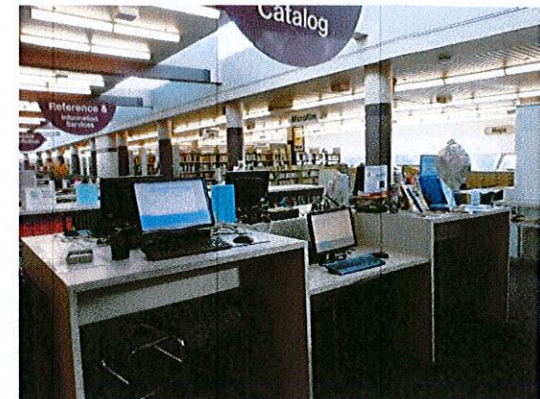
**Photo 3:** Catalogs are provided at standing height desks and a desk with knee and toe clearance. *This is a good example of accessibility.*

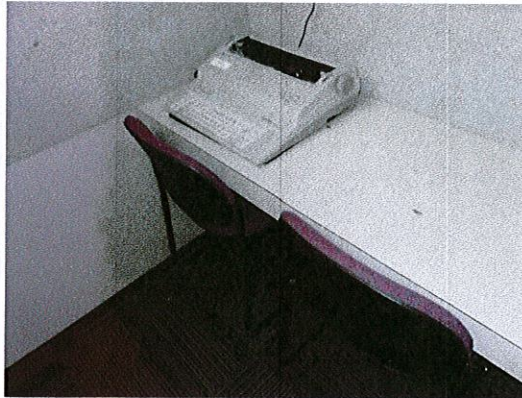
**Photo 4:** Relocate a typewriter to an accessible location if requested. (The current private cubicles are too small.)

<b>Typewriter Rooms- 2nd Floor</b>									
14D2 15718	Relocate program as necessary to an accessible location to provide program access. MN 1341 1104.4 <i>The private typewrite rooms currently have a 30" clear door and the space is 54" wide overall. Relocate 1 of the typewriters to an accessible location as needed. Photo 4.</i>	1	\$0	\$0	1				
				<b>Priority # 1 Total</b>	<b>\$101,500</b>

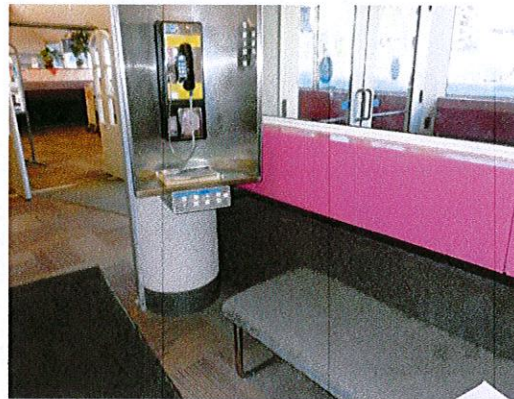
**Photo 5:** Relocate the bench so it does not obstruct the approach to the pay phone. Lower the phone so the coin slot is 48" max AFF (currently 60").

Location JQP # / Item #	Solution / Comments	Qty	Unit Cost	Total Cost	Priority	Estimated Compl. Date	Person Responsible	Actual Compl. Date	Actual Cost
<b>Pay Phone</b>									
42B	15729 Relocate the existing telephone to a location where clear floor space is available or remove obstruction that obstructs the clear floor space at the telephone. ICC / ANSI 604.2.1 <i>Relocate the bench that is currently positioned below the telephone. Photo 5.</i>	1	\$100	\$100	2				
42E	15728 Lower the telephone so the highest operable part is no higher 48" above the floor. ICC / ANSI 704.2.2 <i>Currently at 60". (Or remove the phone.) Photo 5.</i>	1	\$100	\$100	2				
				<i>Location Subtotal:</i>					\$200
				<b>Priority # 2 Total</b>					<b>\$4,450</b>

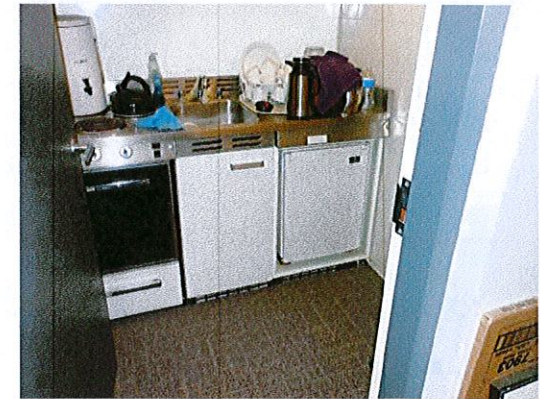
**Photo 6:** View of small kitchen in the closet of the Round Conference Room.

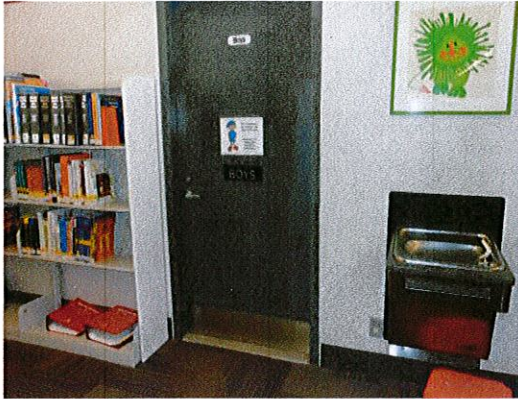
**Photo 7:** The book case currently obstructs the clearance on the push side of the boy's and girl's toilet rooms.

Location JQP # / Item #	Solution / Comments	Qty	Unit Cost	Total Cost	Priority	Estimated Compl. Date	Person Responsible	Actual Compl. Date	Actual Cost
<b>Boy's Toilet Room- 1st Floor</b>									
22-20C1 15740	Relocate object to achieve needed maneuvering clearance on the push side of the door. ICC / ANSI 404.2.3, Table 404.2.3.1 <i>The bookcase currently obstructs the approach on the push side of the door. Photo 7.</i>	1	\$50	\$50	3				
22B 15732	Install signage with appropriate raised and Braille lettering. MN 1341 1110.2 <i>The sign is currently mounted on the door.</i>	1	\$40	\$40	3				
22E1 15733	Enlarge to provide a fully compliant 60" minimum wide toilet stall. (Currently an alternate stall is provided). MN 1341 604.3.1 <i>Consider modifying this location to meet children's standards (signs indicate this location is for children's use only).</i>	1	\$1,350	\$1,350	3				
22H1 15736	Provide staple style pulls on both sides of the accessible stall door near the latch. ANSI 604.8.3	1	\$50	\$50	3

Location JQP # / Item #	Solution / Comments	Qty	Unit Cost	Total Cost	Priority	Estimated Compl. Date	Person Responsible	Actual Compl. Date	Actual Cost
<b>Girl's Toilet Room- 1st Floor</b>									
22-20C1 15749	Relocate object to achieve needed maneuvering clearance on the push side of the door. ICC / ANSI 404.2.3, Table 404.2.3.1 <i>The bookcase currently obstructs the approach on the push side of the door. Photo 7.</i>	1	\$50	\$50	3				
22B 15741	Install signage with appropriate raised and Braille lettering. MN 1341 1110.2 <i>The sign is currently mounted on the door.</i>	1	\$40	\$40	3				
22E1 15742	Enlarge to provide a fully compliant 60" minimum wide toilet stall. (Currently an alternate stall is provided). MN 1341 604.3.1 <i>Consider modifying this location to meet children's standards (signs indicate this location is for children's use only).</i>	1	\$1,350	\$1,350	3				
22H1 15745	Provide staple style pulls on both sides of the accessible stall door near the latch. ANSI 604.8.3	1	\$50	\$50	3

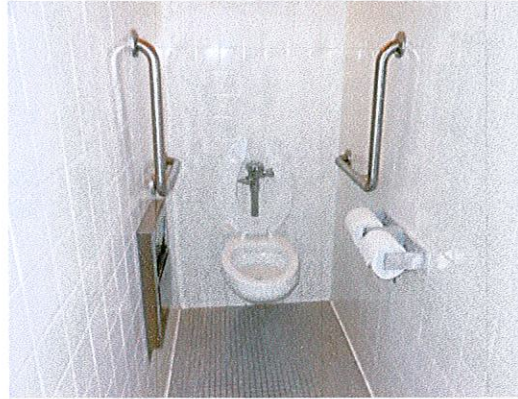
**Photo 8:** View of typical toilet room. Ambulatory accessible stalls are provided, but there is not a 60" wide accessible stall in the building.

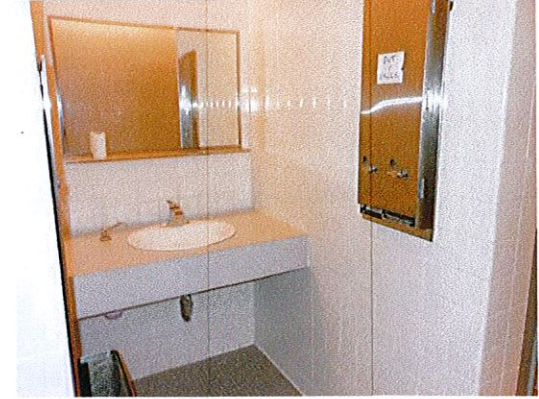
**Photo 9:** Lower the mirror to 40" maximum (or add an additional mirror).

22V	15708 Install a full-height mirror or provide a mirror where the bottom of the reflective surface is no higher than 40" above the floor. MN 1341 603.3 <i>Currently at 49". Photo 9.</i>	1	\$300	\$300	3				
22Z	15706 Provide a coat hook positioned so the highest operable part is no higher than 48". ICC / ANSI 604.11	1	\$50	\$50	3				
				<i>Location Subtotal:</i>					\$2,240

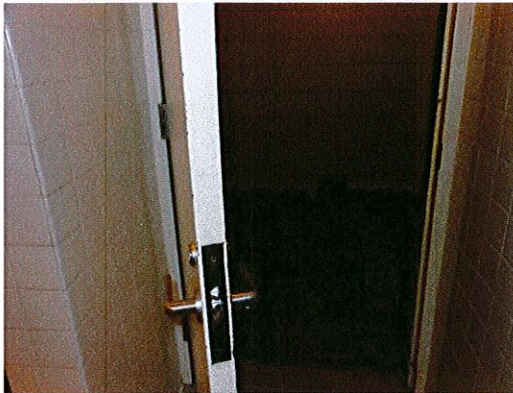
**Photo 10:** Maneuvering clearance is not currently provided on the pull (interior) side of the toilet rooms in the lower level.

Location	Solution / Comments	Qty	Unit Cost	Total Cost	Priority	Estimated Compl. Date	Person Responsible	Actual Compl. Date	Actual Cost
JQP # / Item #									
<b>Girl's Toilet Room- 1st Floor</b>									
22P5 15747	Lower lavatory so top edge is no higher than 34" AFF. ICC / ANSI 606.3 <i>Currently at 35".</i>	1	\$500	\$500	4				
<b>Gold Meeting Room- Ground Level</b>									
20P 15784	Lower the window in the door (or the sidelite) so the bottom is at 43" maximum. ICC / ANSI 404.2.10	1	\$250	\$250	4				
<b>Green Meeting Room- Ground Level</b>									
20P 15806	Lower the window in the door (or the sidelite) so the bottom is at 43" maximum. ICC / ANSI 404.2.10	1	\$250	\$250	4				
<b>Men's Toilet Room- 2nd Floor</b>									
22P5 15715	Lower lavatory so top edge is no higher than 34" AFF. ICC / ANSI 606.3 <i>Currently at 35".</i>	1	\$500	\$500	4				
<b>Men's Toilet Room- Ground Level</b>									
22-20B0 15785	Install an automatic door opener to address non-compliant maneuvering clearance at the door. (Note: Automatic door opener is not required) ICC / ANSI 404.2.3, Table 404.2.3.1 <i>Currently provides 0". Photo 10.</i>	1	\$1,500	\$1,500	4
