## **Grant Community Club**

Accessibility Review

Grant Community Club

City of Duluth, MN

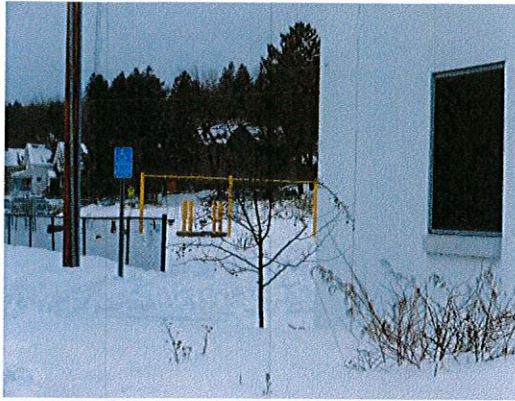
**Photo 1:** There is 1 sign designating an accessible parking space.

Location JQP # / Item #	Solution / Comments	Qty	Unit Cost	Total Cost	Priority	Estimated Compl. Date	Person Responsible	Actual Compl. Date	Actual Cost
<b>Furnace Room</b>									
40B 16314	Provide compliant raised and Braille permanent room identification signage. MN 1341 1110.2	1	\$40	\$40	3				
<b>Janitor's Closet</b>									
20D 16338	Provide door hardware that does not require grasping, pinching or twisting to operate, such as lever. ICC / ANSI 404.2.6	1	\$250	\$250	3				
<b>Kitchen</b>									
40B 16310	Provide compliant raised and Braille permanent room identification signage. MN 1341 1110.2	1	\$40	\$40	3				
<b>Office / Craft Room</b>									
20D 16339	Provide door hardware that does not require grasping, pinching or twisting to operate, such as lever. ICC / ANSI 404.2.6	1	\$250	\$250	3				
<b>Parking</b>									
05H 16341	Stripe to provide an accessible parking stall that is 8' wide with an adjacent 8' access aisle. It is preferred that the access aisle be located on the passenger side of the vehicle. MN 1341 502.4.2 <i>There is 1 parking space designated with a sign. The parking space was covered by snow at the time of site visit. Ensure that the accessible space is 8' wide minimum with an adjacent 8' aisle. Photo 1.</i>	1	\$150	\$150	3

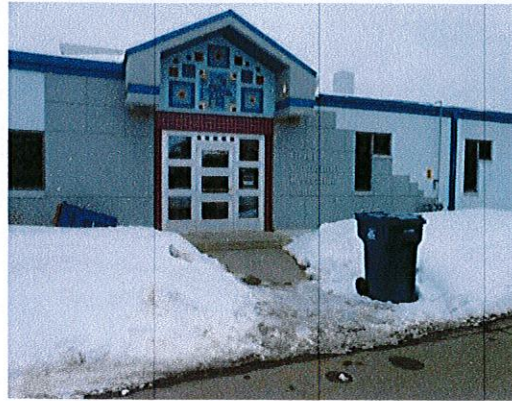
**Photo 2:** Create an accessible route to the main entry. There is currently a step.

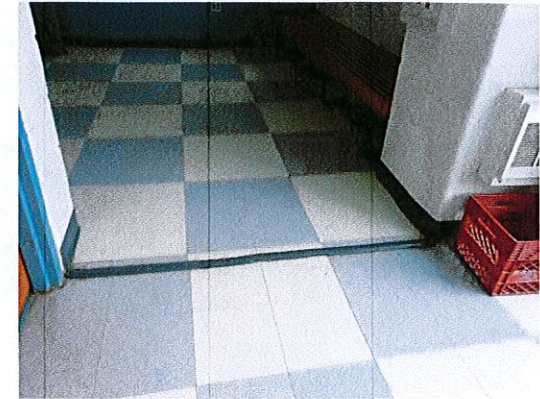
**Photo 3:** Eliminate the 1" rise where the addition connects to the original structure.

Location	Solution / Comments		Qty	Unit Cost	Total Cost	Priority	Estimated Compl. Date	Person Responsible	Actual Compl. Date	Actual Cost
JQP # / Item #										
<b>Corridor</b>										
14C	16340	Bevel abrupt rise between 1/4" and 1/2" with a maximum slope of 1:2, and bevel abrupt rises greater than 1/2" with a maximum slope of 1:12 (8.33%). ICC / ANSI 303.3 <i>There is currently a 1" rise where the addition connects to the original structure. Photo 3.</i>	6	\$100	\$600	2				
					<b>Priority # 2 Total</b>	<b>\$600</b>

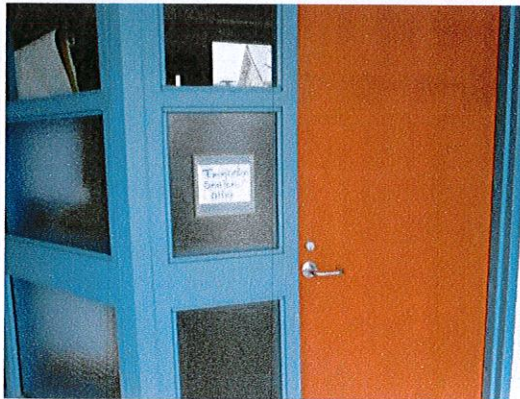
**Photo 4:** Typical hardware is lever style and raised and braille signs are provided throughout the building. *This is a good example of accessibility.* Remove the paper that is covering the signs.

Location JQP # / Item #	Solution / Comments	Qty	Unit Cost	Total Cost	Priority	Estimated Compl. Date	Person Responsible	Actual Compl. Date	Actual Cost
<b>Building Wide</b>									
40B 16342	Provide compliant raised and Braille permanent room identification signage. MN 1341 1110.2 <i>Remove the paper that is currently covering many of the raised and braille signs. Photo 1.</i>	1	\$0	\$0	4				
<b>Drinking Fountain</b>									
41A1 16316	Provide a minimum of one drinking fountain that has a 36" spout height accessible for persons using wheelchairs (low) and one standard height (high) drinking fountain with a spout height 38" minimum and 43" maximum for persons who have difficulty bending or stooping. ANSI 602.4 <i>There is currently 1 drinking fountain at 34".</i>	1	\$1,500	\$1,500	4				
<b>Furnace Room</b>									
20B 16313	Re-hinge / relocate door to provide needed maneuvering clearance on the latch pull side of the door. ICC / ANSI 404.2.3, Table 404.2.3.1 <i>Currently provides 10".</i>	1	\$400	\$400	4

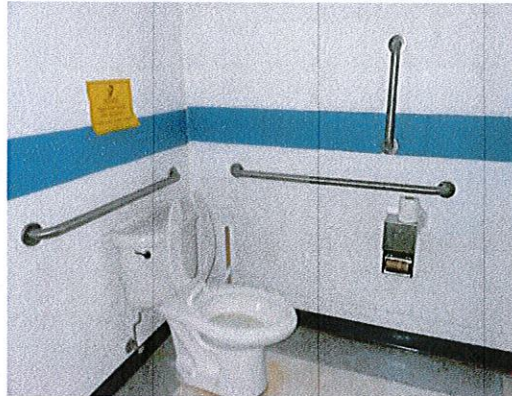
**Photo 5:** View of single-user toilet room. *This is a good example of accessibility.*

Location	Solution / Comments		Qty	Unit Cost	Total Cost	Priority	Estimated Compl. Date	Person Responsible	Actual Compl. Date	Actual Cost
JQP # / Item #										
<b>Storage (former concessions)</b>										
40B	16326	Provide compliant raised and Braille permanent room identification signage. MN 1341 1110.2	1	\$40	\$40	3				
<b>Unisex Toilet Room</b>										
22Z	16315	Provide a coat hook positioned so the highest operable part is no higher than 48". ICC / ANSI 604.11 <i>Currently at 60". Photo 5.</i>	1	\$50	\$50	3				
					<b>Priority # 3 Total</b>	<b>\$820</b>
