Piedmont Community Club

Piedmont Community Club is a 2-story building- the lower level is a warming house with toilet rooms; the upper level has a large open meeting/assembly room, full kitchen and toilet rooms. There is an accessible route from the small parking lot to the upper level entry, but not to the lower level entry. There is not an interior route between the 2 levels (only exterior stairs). Currently none of the toilet rooms are accessible and the kitchen does not provide any features of accessibility.

Transition Plan - (location/priority)

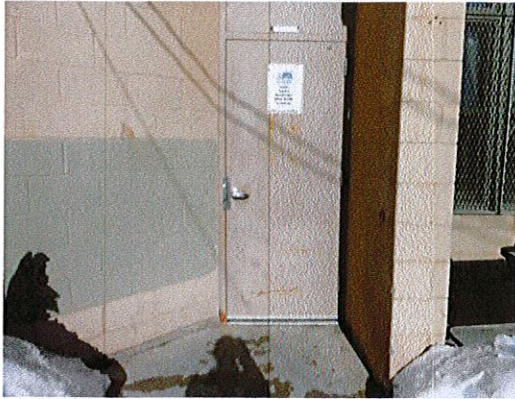
Photo 1: View of upper level entry. Maneuvering clearance is not currently provided at the main door due to the angle of the wall.

Main Entry- Upper Level									
12C 16179	Relocate door and frame to provide an appropriate approach to the door. ICC / ANSI 404.2.3.1 <i>Photo 1.</i>	1	\$1,500	\$1,500	3

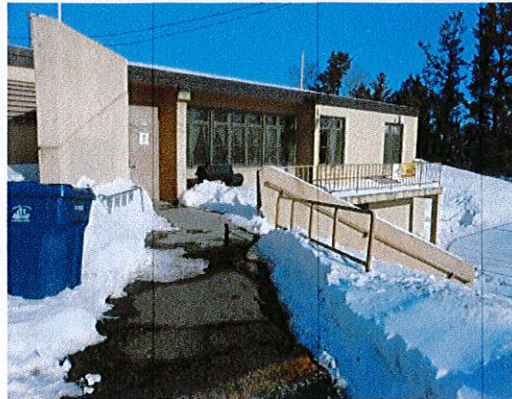
Photo 2: There is an on-grade entry to upper level from the parking lot. There is not currently a route to the lower level. (There is no interior route between the 2 levels, only exterior stairs.)

Location	Solution / Comments	Qty	Unit Cost	Total Cost	Priority	Estimated Compl. Date	Person Responsible	Actual Compl. Date	Actual Cost
JQP # / Item #									
Warming House- Lower Level									
08A	16202	1	\$20,000	\$20,000	2				
	Provide an accessible route. IBC 1104 <i>There is not currently an accessible route to the lower level; exterior stairs are provided from the parking lot and adjacent to the building. Photo 6.</i>								
				Priority # 2 Total	\$20,000

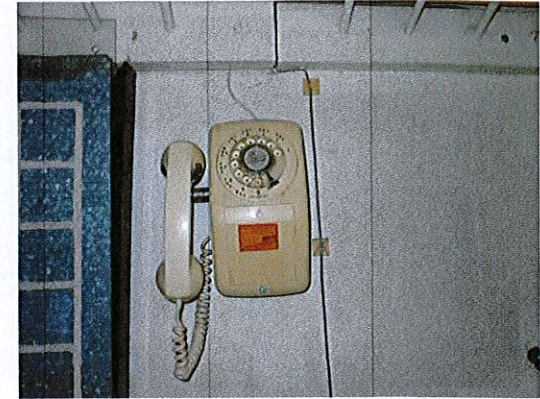
Photo 3: Replace the rotary style phone with a push button style.

Location	Solution / Comments	Qty	Unit Cost	Total Cost	Priority	Estimated Compl. Date	Person Responsible	Actual Compl. Date	Actual Cost
JQP # / Item #									
Telephone- Upper Level									
42D	16201 Provide a telephone with push button controls or automatic dial. ICC / ANSI 704.2.2 <i>There is currently a rotary dial phone. (Or remove the phone.) Photo 3.</i>	1	\$100	\$100	3				
Warming Room- Lower Level									
14G2	16225 Remove, relocate or replace object so it is not a protruding object for persons with visual impairments. ICC / ANSI 307.1 <i>The heater currently protrudes at a height of 73". Photo 5.</i>	1	\$100	\$100	3				
Women's Toilet Room- Lower Level									
22B	16217 Install signage with appropriate raised and Braille lettering. MN 1341 1110.2	1	\$40	\$40	3				
22H1	16222 Provide staple style pulls on both sides of the accessible stall door near the latch. ANSI 604.8.3	1	\$50	\$50	3

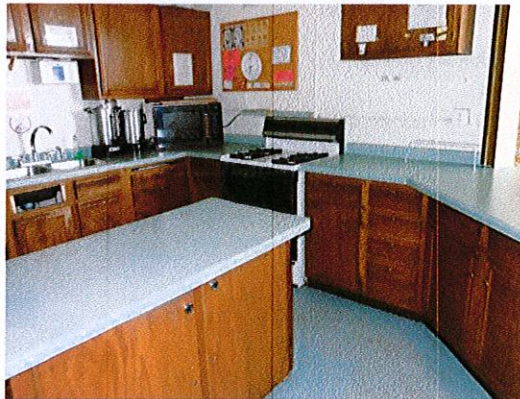
Photo 4: View of kitchen. There are currently no features of accessibility.

Location JQP # / Item #	Solution / Comments	Qty	Unit Cost	Total Cost	Priority	Estimated Compl. Date	Person Responsible	Actual Compl. Date	Actual Cost
Kitchen- Upper Level									
25J9 16180	Create an accessible kitchen, including: roll under work surface, roll under sink, range with front or side controls, and compliant clearances. ANSI 804 Photo 4.	1	\$7,000	\$7,000	4				
Men's Toilet Room- Lower Level									
22-20B 16207	Re-hinge / relocate door to provide needed maneuvering clearance on the latch pull side of the door. ICC / ANSI 404.2.3, Table 404.2.3.1 Currently provides 2".	1	\$750	\$750	4				
22E1 16214	Enlarge to provide a fully compliant 60" minimum wide toilet stall. (Currently an alternate stall is provided). MN 1341 604.3.1 Creating an accessible toilet room would require removing the other fixture.	1	\$1,350	\$1,350	4				
				<i>Location Subtotal:</i>					\$2,100
Men's Toilet Room- Upper Level

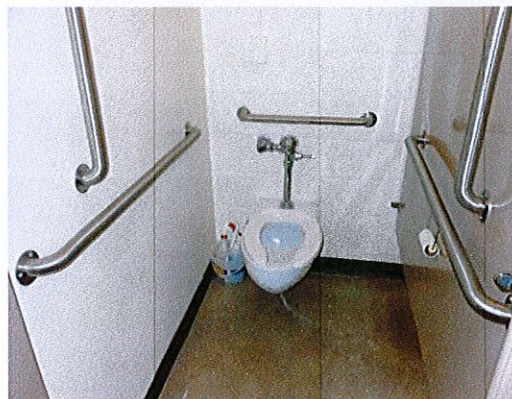
Photo 5: The upper level toilet rooms provide an ambulatory accessible stall, but not a 5' accessible stall.

22-20B 16182	Re-hinge / relocate door to provide needed maneuvering clearance on the latch pull side of the door. ICC / ANSI 404.2.3, Table 404.2.3.1 Currently provides 2".	1	\$750	\$750	4				
22E1 16189	Enlarge to provide a fully compliant 60" minimum wide toilet stall. (Currently an alternate stall is provided). MN 1341 604.3.1 Creating an accessible toilet room would require removing the other fixture. Photo 6.	1	\$1,350	\$1,350	4				
				<i>Location Subtotal:</i>					\$2,100

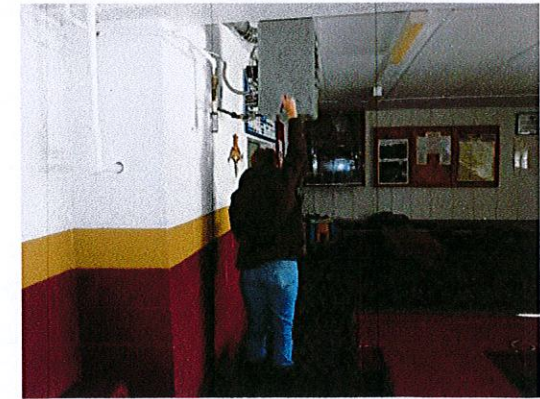
Photo 6: The heater in the warming house currently creates a protruding hazard.
