## **Wheeler Fieldhouse**

**Wheeler Fieldhouse**

**Accessibility Review**

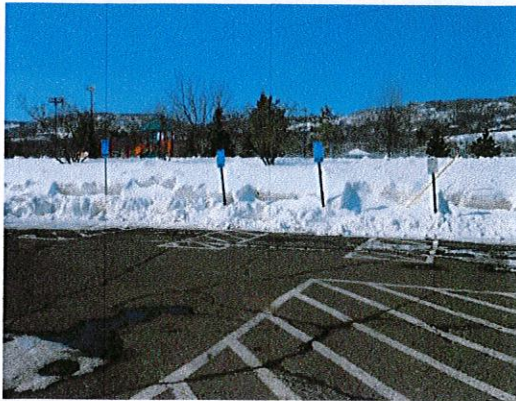
**Photo 1:** View of accessible parking. Re-stripe to provide an 8' wide access aisle. (Can be shared between 2 spaces.)

Location JQP # / Item #	Solution / Comments	Qty	Unit Cost	Total Cost	Priority	Estimated Compl. Date	Person Responsible	Actual Compl. Date	Actual Cost
<b>Men's Toilet Room</b>									
22B 16110	Install signage with appropriate raised and Braille lettering. MN 1341 1110.2	1	\$40	\$40	3				
22H1 16118	Provide staple style pulls on both sides of the accessible stall door near the latch. ANSI 604.8.3	1	\$50	\$50	3				
22J 16117	Provide stall door hardware that does not require grasping, pinching or twisting to operate. ICC ANSI 309.4	1	\$50	\$50	3				
22K6 (MN) 16115	Remove the existing grab bar configuration and replace with a compliant grab bar configuration. MN 1341 604.5.1 ANSI 604.5.2	1	\$400	\$400	3				
22Q 16112	Insulate or otherwise protect exposed pipes at lavatory. ICC / ANSI 606.6	1	\$50	\$50	3				
				<i>Location Subtotal:</i>					\$590
<b>Parking</b>									
05H 16104	Stripe to provide an accessible parking stall that is 8' wide with an adjacent 8' access aisle. It is preferred that the access aisle be located on the passenger side of the vehicle. MN 1341 502.4.2  <i>There are currently 3 spaces designated as accessible- each 9' wide with an adjacent 5' wide aisle. Re-stripe so each space is 8' wide with an adjacent 8' wide aisle (aisle can be shared between 2 spaces). Photo 1.</i>	3	\$150	\$450	3

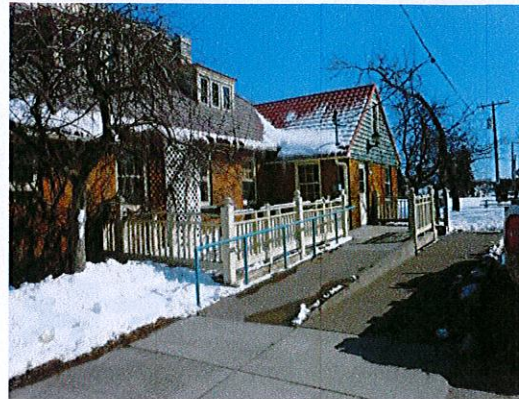
**Photo 2:** Add a handrail to the open side of the ramp leading to the main entry.

Location JQP # / Item #	Solution / Comments	Qty	Unit Cost	Total Cost	Priority	Estimated Compl. Date	Person Responsible	Actual Compl. Date	Actual Cost
<b>Exterior Route</b>									
09B 16965	Install a fully compliant handrail where missing, so handrails are provided on both sides of the sloped surface. ANSI 405.8 <i>Consider adding a handrail to the open side. The slope is less than 5% so this is not technically a ramp. Photo 2.</i>	30	\$25	\$750	4				
<b>Kitchen</b>									
20A 16107	Widen door opening to provide a minimum 32" clear opening. ICC / ANSI 404.2.2 <i>Currently provides 29" clear opening.</i>	1	\$1,500	\$1,500	4				
25J1.1 16108	Modify height of sink counter to 34" maximum. ANSI 804.4 <i>There are currently no features of accessibility provided in the kitchen. (Because the range has been removed this is considered a 'kitchenette' and knee and toe clearance is not required at the sink or work surface.) Photo 4.</i>	1	\$1,000	\$1,000	4

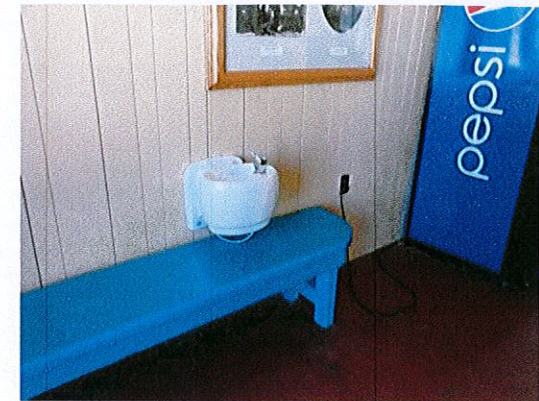
**Photo 3:** Relocate the bench; it currently obstructs access to the drinking fountain.

Location JQP # / Item #	Solution / Comments	Qty	Unit Cost	Total Cost	Priority	Estimated Compl. Date	Person Responsible	Actual Compl. Date	Actual Cost
<b>Drinking Fountain</b>									
16121	<i>Relocate the bench that currently obstructs the clear floor space at the drinking fountain. Photo 3.</i>	1	\$0	\$0	3				
41A1 16120	Provide a minimum of one drinking fountain that has a 36" spout height accessible for persons using wheelchairs (low) and one standard height (high) drinking fountain with a spout height 38" minimum and 43" maximum for persons who have difficulty bending or stooping. ANSI 602.4 <i>There is currently 1 drinking fountain with a 33" spout height.</i>	1	\$1,500	\$1,500	3				
				<i>Location Subtotal:</i>					\$1,500
<b>Gathering Room</b>									
14G1 16109	Eliminate protruding hazard by installing end panels or other object to direct a person with visual impairments using proper cane technique around the potential hazard. ICC / ANSI 307.1 <i>The mantle of the fireplace currently protrudes 10" at a height of 57".</i>	1	\$200	\$200	3

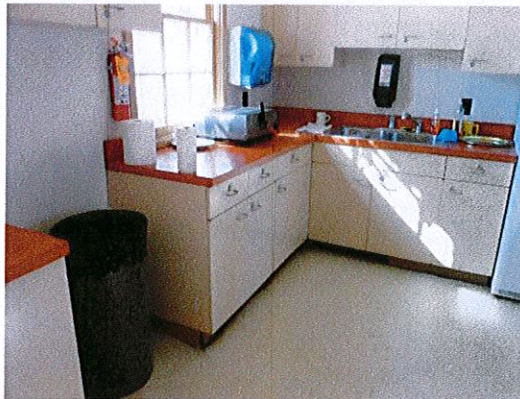
**Photo 4:** View of the kitchen. The range has been removed, so this is a 'kitchenette' (which only requires a parallel approach to the sink instead of a roll-under sink).

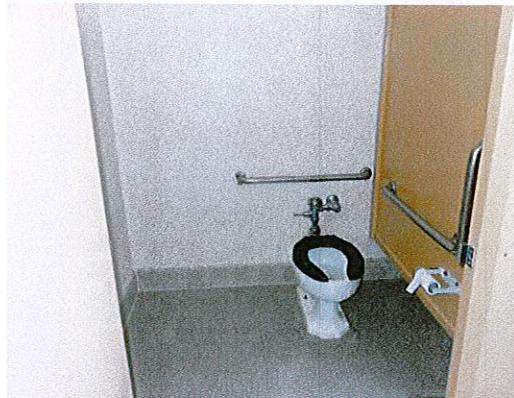
**Photo 5:** View of men's toilet room. Remodeling has occurred to provide features of accessibility.

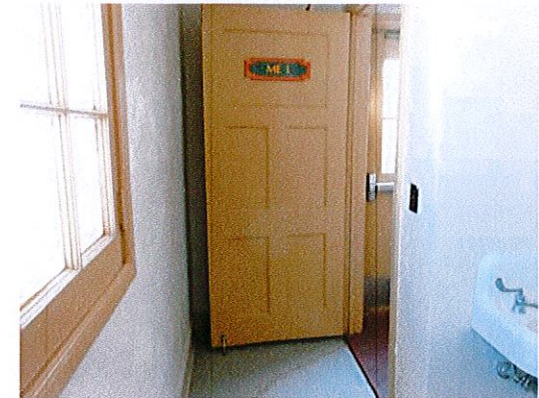
**Photo 6:** The entry to the men's toilet room does not currently provide maneuvering clearance. Propping the door in the 'open' position is a good example.

<i>Location Subtotal:</i>					\$2,500
<b>Men's Toilet Room</b>									
22-20C 16111	Relocate door and frame to provide needed maneuvering clearance at the door. ICC / ANSI 404.2.3, Table 404.2.3.1 <i>The depth at the door is currently 41" (vs. 48" minimum). The door was propped in the 'open' position at the time of site visit. Photo 6.</i>	1	\$1,500	\$1,500	4				
22G (MN) 16114	Modify to provide a minimum clearance of 48" in front of the water closet. MN 1341 604.3.1 <i>The stall is currently 5' x 5'. Photo 5.</i>	1	\$1,000	\$1,000	4				
22M 16116	Provide a water closet with a seat height 17"-19" above the floor. ANSI 604.4 <i>Currently at 16 1/2".</i>	1	\$750	\$750	4				
22P 16113	Raise the lavatory to provide a minimum knee clearance height of 27". ICC / ANSI 606.2 <i>The wall hung sink currently provides 26" knee clearance.</i>	1	\$1,000	\$1,000	4				
				<i>Location Subtotal:</i>					\$4,250
