## **Chambers Grove- Bathroom Building**

Accessibility Review

Transition Plan - (location/priority)

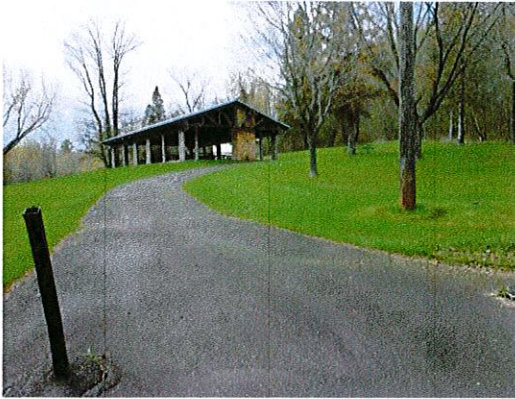
**Photo 1:** The slope of the route from parking to the picnic pavilion is currently 9.5%.

Location JQP # / Item #	Solution / Comments	Qty	Unit Cost	Total Cost	Priority	Estimated Compl. Date	Person Responsible	Actual Compl. Date	Actual Cost
<b>Men's Toilet Room</b>									
08D	16718 Bevel abrupt rises in the sidewalk. ANSI 303.3 <i>There is currently a 3" rise at the concrete stoop. Photo 3.</i>	1	\$50	\$50	3				
22B	16713 Install signage with appropriate raised and Braille lettering. MN 1341 1110.2	1	\$40	\$40	3				
22Q	16716 Insulate or otherwise protect exposed pipes at lavatory. ICC / ANSI 606.6	1	\$50	\$50	3				
22Y	16715 Lower urinal so the lip is no higher than 17" above the floor. ICC / ANSI 605.2 <i>Currently at 24". Photo 5.</i>	1	\$650	\$650	3				
				<i>Location Subtotal:</i>					\$790
<b>Route</b>									
09K	16707 Reconstruct ramp to provide an maximum 1:12 (8.33%) slope. ADA 405.2 <i>The route from the parking lot to the picnic pavillion is as steep as 9.5%. The route from the picnic pavillion to the comfort station is 19.8% for a distance of approximately 45'. If the slope of the route is 5%-8.33% it is a ramp and will also need handrails. Photos 1 and 2.</i>	1	\$15,000	\$15,000	3

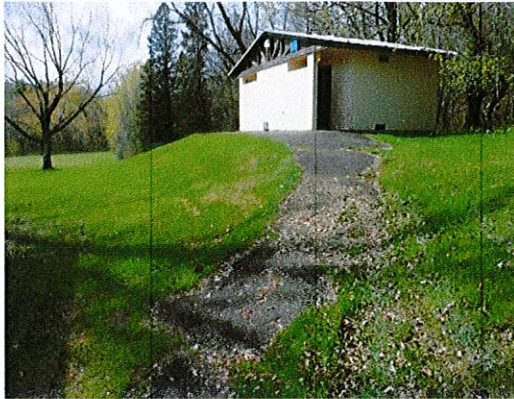
**Photo 2:** The slope of the route from the picnic pavilion to the toilet room is currently 19.8%.

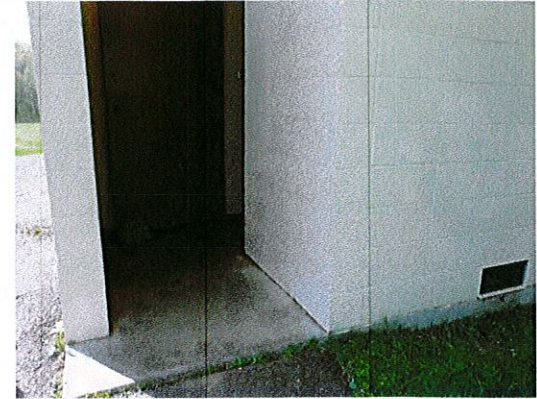
**Photo 3:** Eliminate the rise at the concrete stoop at the toilet room entry.

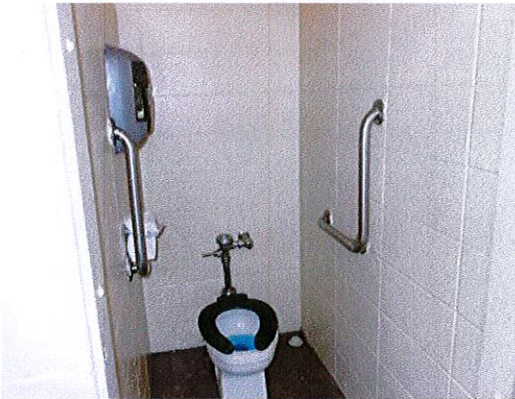
**Photo 4:** An ambulatory accessible stall has been provided, but not a 5' wide stall.

Location JQP # / Item #	Solution / Comments	Qty	Unit Cost	Total Cost	Priority	Estimated Compl. Date	Person Responsible	Actual Compl. Date	Actual Cost
<b>Men's Toilet Room</b>									
22-20B 16714	Re-hinge / relocate door to provide needed maneuvering clearance on the latch pull side of the door. ICC / ANSI 404.2.3, Table 404.2.3.1 <i>The door is currently held in the 'open' position.</i>	1	\$750	\$750	4				
22E3 16717	Create a fully compliant 60" minimum wide toilet stall by combining two existing stalls and removing one toilet. Ensure that the new stall provides 48" minimum in front of the toilet, side and rear grab bars, toilet paper dispenser located below the horizontal grab bar, a low coat hook, easily operable stall locking hardware and staple style pulls on both sides of the stall door. MN 1341 604.3.1 <i>Creating an accessible 5' wide stall would require removing 1 of the 2 fixtures. Photo 4.</i>	1	\$1,350	\$1,350	4

<i>Location Subtotal:</i>					\$2,100
<b>Women's Toilet Room</b>									
22-20B 16711	Re-hinge / relocate door to provide needed maneuvering clearance on the latch pull side of the door. ICC / ANSI 404.2.3, Table 404.2.3.1 <i>The door is currently held in the 'open' position.</i>	1	\$750	\$750	4				
22E3 16712	Create a fully compliant 60" minimum wide toilet stall by combining two existing stalls and removing one toilet. Ensure that the new stall provides 48" minimum in front of the toilet, side and rear grab bars, toilet paper dispenser located below the horizontal grab bar, a low coat hook, easily operable stall locking hardware and staple style pulls on both sides of the stall door. MN 1341 604.3.1 <i>Creating an accessible 5' wide stall would require removing 1 of the 2 fixtures. Photo 4.</i>	1	\$1,350	\$1,350	4				
				<i>Location Subtotal:</i>					\$2,100
				<b>Priority # 4 Total</b>					<b>\$4,200</b>

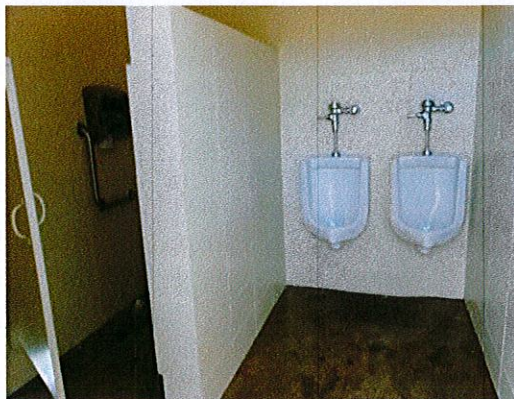
**Photo 5:** Lower 1 of the urinals to 17" max (currently at 24").
