Fire Station 6

Accessibility Review

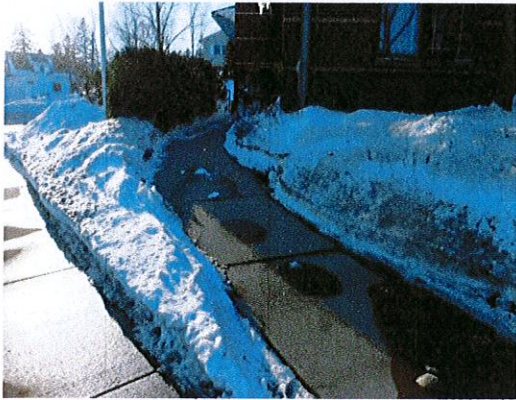
Location JQP # / Item #	Solution / Comments	Qty	Unit Cost	Total Cost	Priority	Estimated Compl. Date	Person Responsible	Actual Compl. Date	Actual Cost
Exterior Route									
09L 15822	Reconstruct the exterior route to provide a maximum slope of 1:20. ANSI 402.2, Exception 1 <i>Currently the exterior route is as steep as 8% for a distance of approximately 18' and 12.2% for a distance of approximately 18'. Ramps (slope 5%-8.33%) are not considered part of an exterior accessible route in MN. Photo 1.</i>	1	\$8,000	\$8,000	2				
				Priority # 2 Total	\$8,000

Photo 1: Modify the route to the main entry so it does not exceed 5% (currently as steep as 12%).

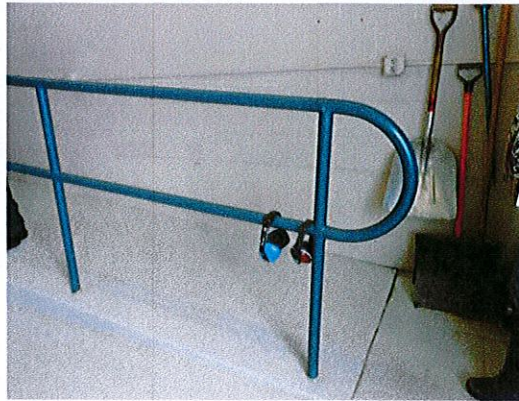
Location JQP # / Item #	Solution / Comments	Qty	Unit Cost	Total Cost	Priority	Estimated Compl. Date	Person Responsible	Actual Compl. Date	Actual Cost
Apparatus Area									
15A 15819	Provide fully compliant handrails on both sides of the sloped surface. ICC ANSI 405.8 <i>There is not currently a handrail on the wall side. The open side currently has a guardrail at 46" AFF. Photo 2.</i>	40	\$25	\$1,000	3				
Locker Room									
22B 15814	Install signage with appropriate raised and Braille lettering. MN 1341 1110.2	1	\$40	\$40	3				
Parking									
05A 15821	Stripe an appropriate number of accessible parking stalls and provide appropriate permanent signage. IBC 1106.1 <i>There is room for 9 vehicles in the lot. Currently none have been designated as accessible. The route from the parking lot is stairs to a secure entry or around the building via the city sidewalk.</i>	1	\$400	\$400	3				
Single User Toilet Room- Lobby

Photo 2: Add handrails at the ramp in the garage area. (Currently a guardrail on the open side.)

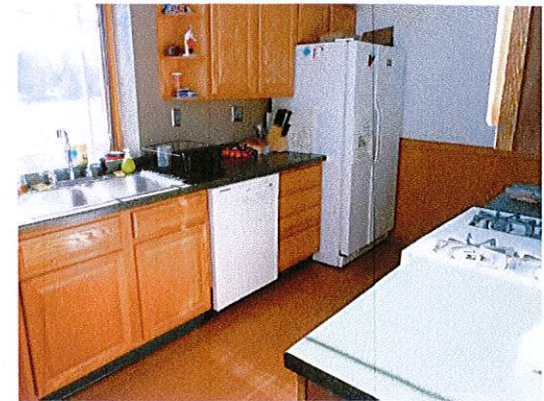
Photo 3: View of kitchen. There are currently no features of accessibility provided.

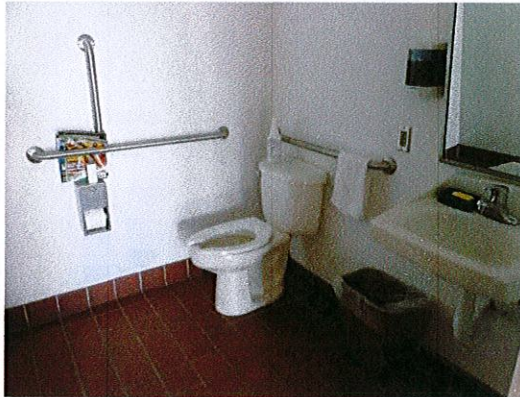
Photo 4: View of lobby toilet room. *This is a good example of accessibility.*

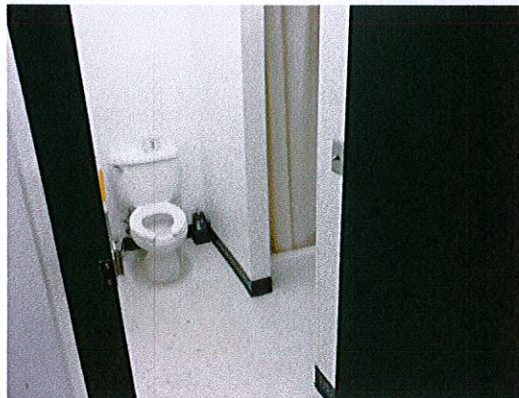
Photo 5: View of locker room. There are currently no features of accessibility provided.

Location JQP # / Item #	Solution / Comments	Qty	Unit Cost	Total Cost	Priority	Estimated Compl. Date	Person Responsible	Actual Compl. Date	Actual Cost
Locker Room									
22C2 (MN) 15815	Relocate the lavatory or enlarge the room to provide a minimum 42" between the lavatory and the center of the water closet. ANSI 604.3.2 <i>The sink is currently within the clearance for the toilet. No action recommended, okay at time of construction. Photo 5.</i>	1	\$0	\$0	4				
24B1 15816	Modify the size of the shower to be either a compliant roll-in shower (minimum 30" x 60") or a compliant transfer shower (36" x 36" exact). MN1341 608.2 <i>The shower is currently 32"x34" with a 5" threshold. Photo 5.</i>	1	\$1,000	\$1,000	4				
				<i>Location Subtotal:</i>					\$1,000
Single User Toilet Room- Lobby									
22N1 15811	Relocate the water closet flush valve so it is located on the open side of the water closet or provide an automatic flush system. MN1341 604.6	1	\$400	\$400	4
