## **Fleet Services**

Accessibility Review

City of Duluth, MN

2013

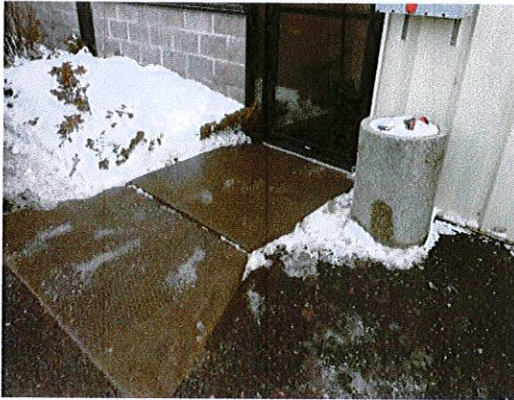
**Photo 1:** Enlarge the concrete pad to provide maneuvering clearance at the main entry.

Location JQP # / Item #	Solution / Comments	Qty	Unit Cost	Total Cost	Priority	Estimated Compl. Date	Person Responsible	Actual Compl. Date	Actual Cost
<b>Building Wide</b>									
20D 15892	Provide door hardware that does not require grasping, pinching or twisting to operate, such as lever. ICC / ANSI 404.2.6	5	\$250	\$1,250	3				
<b>Conference Room</b>									
25J1 15894	Provide accessible faucet hardware. ANSI 804.4, 606.4 <i>Photo 2.</i>	1	\$450	\$450	3				
<b>Employee Entry- West</b>									
08D 15918	Bevel abrupt rises in the sidewalk. ANSI 303.3 <i>Currently a 3" rise.</i>	1	\$200	\$200	3				
<b>Main Entry</b>									
08D 15889	Bevel abrupt rises in the sidewalk. ANSI 303.3 <i>Photo 1.</i>	1	\$500	\$500	3				
12B1 15890	Extend sidewalk to provide appropriate maneuvering clearance on the latch side of the door. ICC / ANSI 404.2.3.1 <i>Photo 1.</i>	1	\$500	\$500	3				
				<i>Location Subtotal:</i>					\$1,000

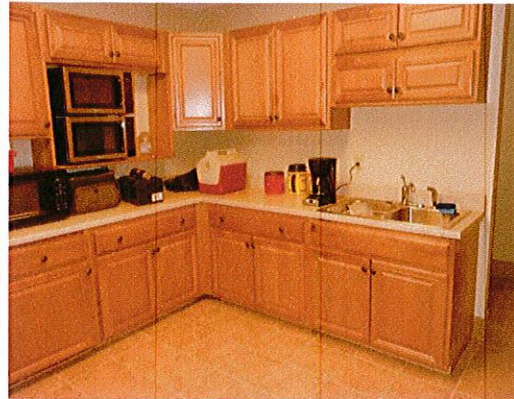
**Photo 2:** View of kitchenette (no range provided). The sink and counters are at 34". *This is a good example of accessibility.*

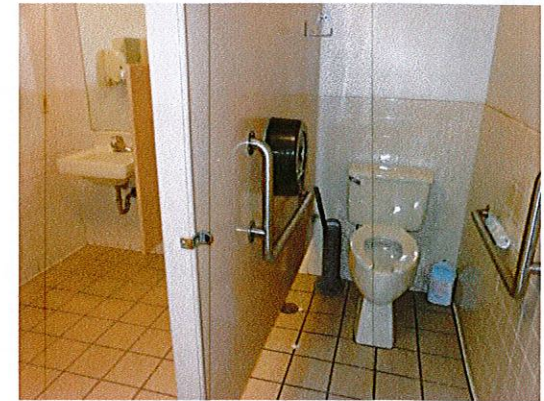
**Photo 3:** View of toilet room. An ambulatory accessible stall is provided, but not a 60" stall.

22-20A 15899	Widen door opening to provide a minimum 32" clear opening. ICC / ANSI 404.2.2 <i>Currently provides a 29" clear opening.</i>	1	\$1,500	\$1,500	4				
22E1 15900	Enlarge to provide a fully compliant 60" minimum wide toilet stall. (Currently an alternate stall is provided). MN 1341 604.3.1	1	\$1,350	\$1,350	4				
22K6 (MN) 15901	Remove the existing grab bar configuration and replace with a compliant grab bar configuration. MN 1341 604.5.1 ANSI 604.5.2	1	\$400	\$400	4				
22Q 15898	Insulate or otherwise protect exposed pipes at lavatory. ICC / ANSI 606.6	1	\$50	\$50	4				
				<i>Location Subtotal:</i>					\$3,300

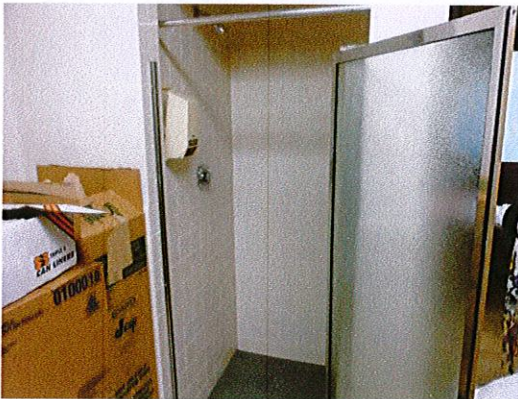
**Photo 4:** View of shower. The shower does not currently provide seat, grab bars or hand held shower wand.

Location JQP # / Item #	Solution / Comments	Qty	Unit Cost	Total Cost	Priority	Estimated Compl. Date	Person Responsible	Actual Compl. Date	Actual Cost
<b>Women's Locker Room</b>									
22-20B 15902	Re-hinge / relocate door to provide needed maneuvering clearance on the latch pull side of the door. ICC / ANSI 404.2.3, Table 404.2.3.1 <i>Currently provides 5 3/4".</i>	1	\$750	\$750	4				
22E1 15904	Enlarge to provide a fully compliant 60" minimum wide toilet stall. (Currently an alternate stall is provided). MN 1341 604.3.1 <i>Photo 3.</i>	1	\$1,350	\$1,350	4				
22Q 15903	Insulate or otherwise protect exposed pipes at lavatory. ICC / ANSI 606.6	1	\$50	\$50	4				
24D 15906	Provide a compliant shower seat. ICC / ANSI 608.4, 610 <i>Photo 4.</i>	1	\$750	\$750	4				
24E 15907	Provide a compliant hand-held shower unit. ICC / ANSI 608.5, 608.6 <i>Photo 4.</i>	1	\$475	\$475	4				
24I 15908	Install compliant shower grab bars. ICC / ANSI 608.3.1 <i>Photo 4.</i>	1	\$400	\$400	4

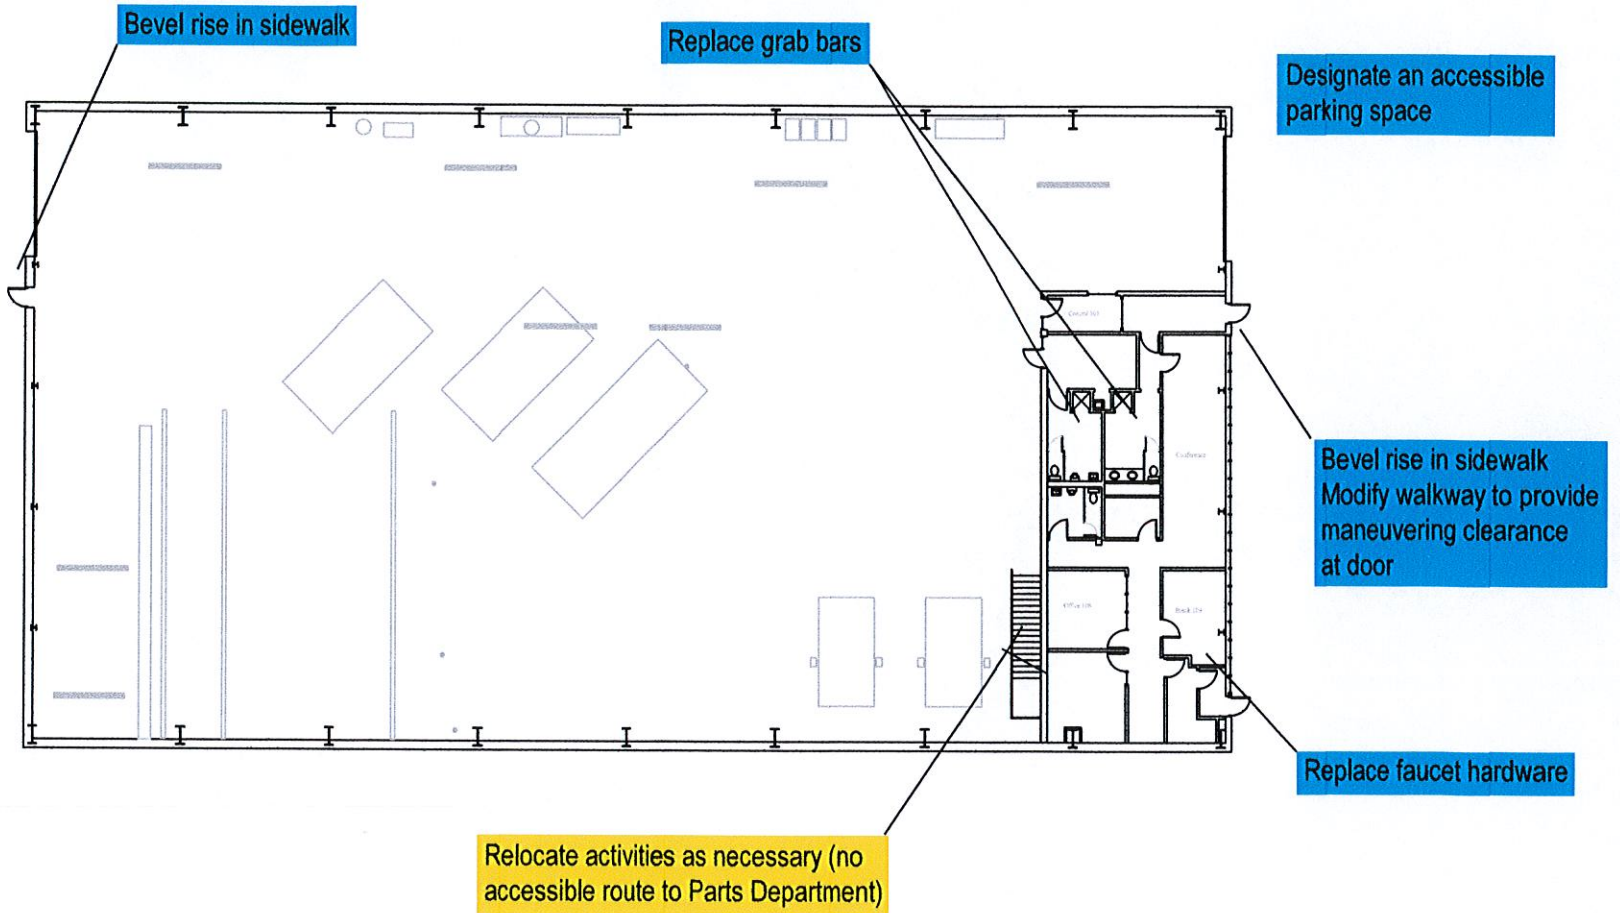
Building Wide

Replace knob style door hardware
