Street Maintenance - West / 40th Toolhouse

Accessibility Review

City of Duluth, MN

2013

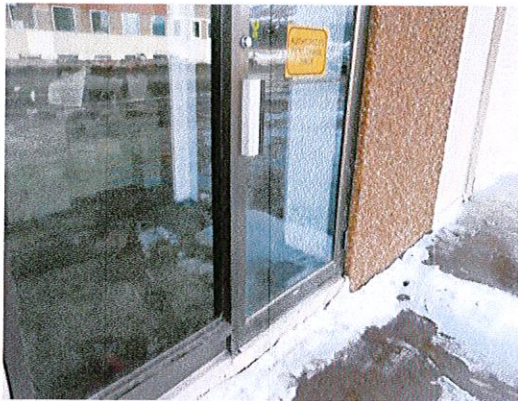
Photo 1: View of main entry. There is currently a rise at the main entry.

Location JQP # / Item #	Solution / Comments	Qty	Unit Cost	Total Cost	Priority	Estimated Compl. Date	Person Responsible	Actual Compl. Date	Actual Cost
Main Entry									
12 15877	Modify to provide an accessible entrance. MN1341 1105.1 <i>There is currently a 6" step up to the main entry. Photo 1.</i>	1	\$1,500	\$1,500	2				
Single User Toilet Room- 1									
22 15879	Enlarge and upgrade the toilet room to be fully accessible. IBC 1109.2 <i>There are 2 single user toilet rooms adjacent to each other; currently neither toilet room provides features of accessibility. Consider modifying to include an accessible shower (there is not currently an accessible route to the shower on the upper level). Photo 3.</i>	1	\$10,000	\$10,000	2				
				Priority # 2 Total	\$11,500

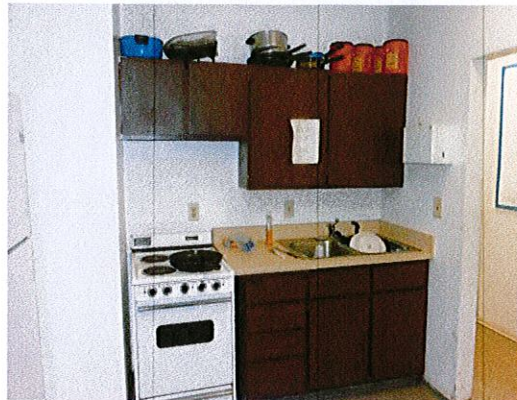
Photo 2: View of break room. The kitchen does not currently provide any features of accessibility.

Location JQP # / Item #	Solution / Comments	Qty	Unit Cost	Total Cost	Priority	Estimated Compl. Date	Person Responsible	Actual Compl. Date	Actual Cost
Break Room									
25J9 15882	Create an accessible kitchen, including: roll under work surface, roll under sink, range with front or side controls, and compliant clearances. ANSI 804 <i>Photo 2.</i>	1	\$7,000	\$7,000	4				
Building Wide									
20D 15881	Provide door hardware that does not require grasping, pinching or twisting to operate, such as lever. ICC / ANSI 404.2.6	6	\$250	\$1,500	4				
Garage / Shop									
41A1 15883	Provide a minimum of one drinking fountain that has a 36" spout height accessible for persons using wheelchairs (low) and one standard height (high) drinking fountain with a spout height 38" minimum and 43" maximum for persons who have difficulty bending or stooping. ANSI 602.4 <i>There is currently 1 drinking fountain at 42".</i>	1	\$1,500	\$1,500	4

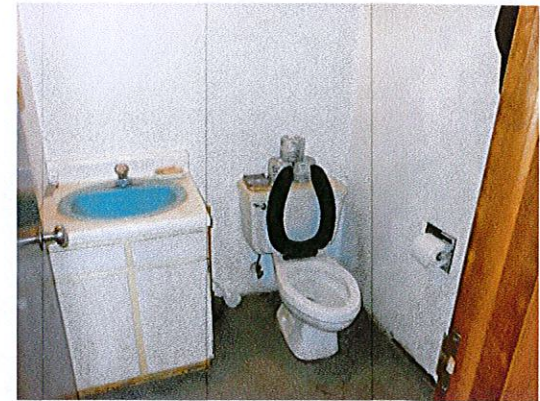
Photo 3: The single user toilet rooms do not currently provide any features of accessibility.

Main Entry									
20M 15878	Provide a smooth surface at the bottom (within 10" of the floor) of the door, that extends the full width of the door. ICC / ANSI 404.2.9	2	\$50	\$100	4				
Single User Toilet Room- 2									
22 15880	Enlarge and upgrade the toilet room to be fully accessible. IBC 1109.2 <i>There are 2 single user toilet rooms adjacent to each other; currently neither toilet room provides features of accessibility.</i>	1	\$10,000	\$10,000	4

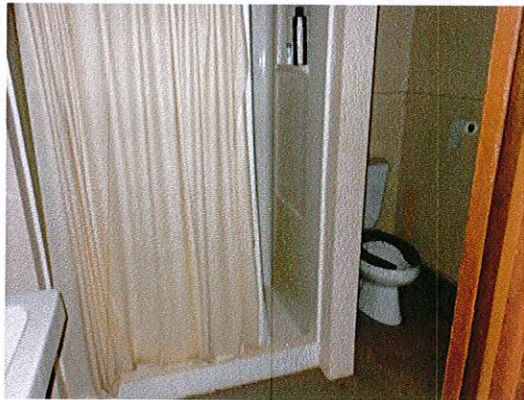
Photo 4: A bathroom is provided on the upper level that includes a toilet and the only shower in the building. There is not currently an accessible route to the upper level.

Upper Level- Bathroom

24	15884	Provide a fully compliant unisex toilet/shower room. IBC 1109.2 <i>There is not currently an accessible route to this level. This is the only location with a shower. Photo 4.</i>	1	\$20,000	\$20,000	4			
----	-------	--	---	----------	----------	---	--	--	--

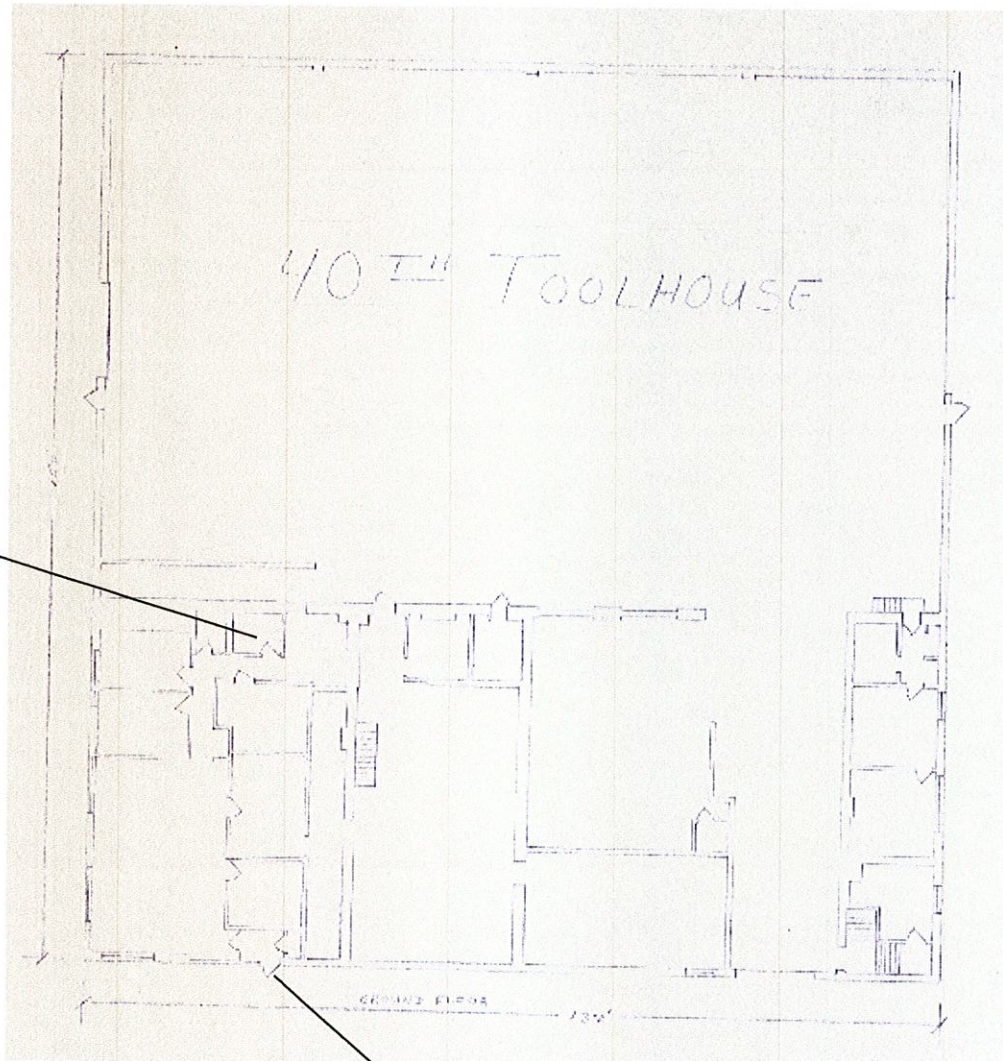
Transition Plan - (location/priority)

Create an accessible toilet room

Relocate activities as necessary
(no accessible route to upper level)

Parking
Designate an accessible parking lot

Install door lever hardware

Create an accessible entry
