Sport Court- Bathroom Building

The Sport Court Bathroom Building is similar to many of the Community Centers. It is a 2 story structure with toilet rooms on both levels. Currently none of the toilet rooms provide any features of accessibility.

Accessibility Review

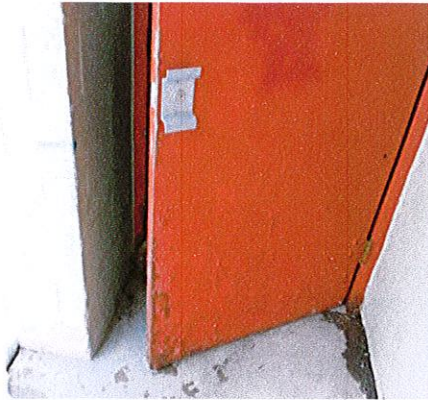
Photo 1: Maneuvering clearance is not currently provided at the entry door.

Location JQP # / Item #	Solution / Comments	Qty	Unit Cost	Total Cost	Priority	Estimated Compl. Date	Person Responsible	Actual Compl. Date	Actual Cost
Main Entry- Upper Level									
20B 16639	Re-hinge / relocate door to provide needed maneuvering clearance on the latch pull side of the door. ICC / ANSI 404.2.3, Table 404.2.3.1 <i>Photo 1.</i>	1	\$400	\$400	4				
Sport Court									
14D1 16644	Provide a fully compliant elevator to provide access between levels. MN 1341 1104.4 and 402.2 <i>There is not currently an interior accessible route between the levels. (On-grade entries are provided to both levels.) There is minimal program interaction between the upper and lower levels; no action recommended at this time. Photo 2.</i>	1	\$0	\$0	4				
Toilet Room- Upper Level									
22 16640	Enlarge and upgrade the toilet room to be fully accessible. IBC 1109.2 <i>There is a small (4'-11" x 4'-6") single user toilet room that does not currently provide any features of accessibility. Photo 3.</i>	1	\$10,000	\$10,000	4

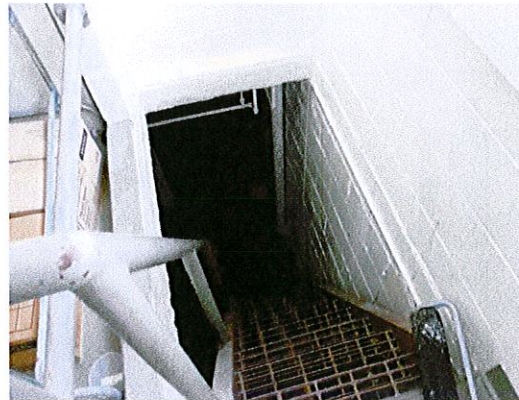
Photo 2: There is not currently an accessible route between levels.

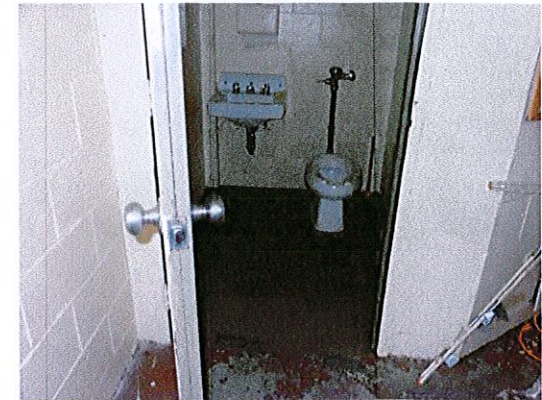
Photo 3: View of upper level toilet room. The toilet room currently provides no features of accessibility.

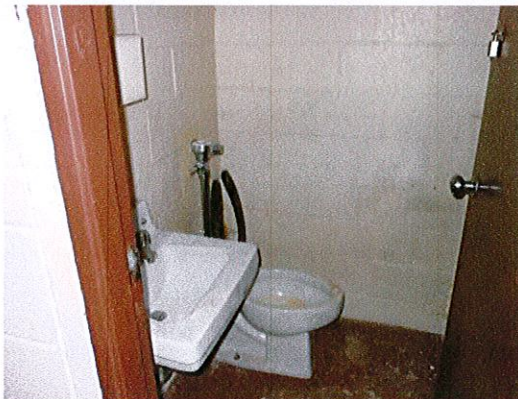
Photo 4: View of lower level toilet room. The toilet room currently provides no features of accessibility.

Toilet Rooms- Lower Level									
22 16643	Enlarge and upgrade the toilet room to be fully accessible. IBC 1109.2 <i>There are 2 small (4'-6" x 4'-1") single user toilet rooms that do not currently provide any features of accessibility. Photo 4.</i>	2	\$10,000	\$20,000	4				
				Priority # 4 Total	\$30,400
