Duluth Heights Community Club

Accessibility Review

Transition Plan - (location/priority)

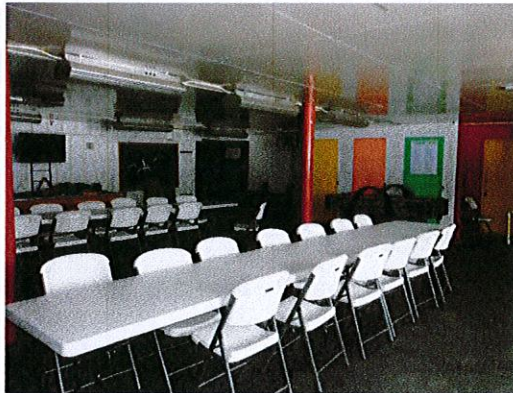
Photo 9: The apartment is now used by the community club. There is not currently an accessible route and there are no features of accessibility provided at the kitchen or bathroom.

Location JQP # / Item #	Solution / Comments	Qty	Unit Cost	Total Cost	Priority	Estimated Compl. Date	Person Responsible	Actual Compl. Date	Actual Cost
Former Apartment									
14D2 16382	Relocate program as necessary to an accessible location to provide program access. MN 1341 1104.4 <i>There is not currently an accessible route to the 3rd story (former apartment). It appears the 3rd story is currently being used for office space and a work room. Photo 9.</i>	1	\$0	\$0	1				
Main Entry									
12 16359	Modify to provide an accessible entrance. MN1341 1105.1 <i>There is an accessible route from the street to a side entry. Ensure the side entry is unlocked at all times the main entry is unlocked.</i>	1	\$0	\$0	1				
				Priority # 1 Total	\$0
